T H A M E S V A L L E Y

1st April 1993

Mortimer West End Chapel Restoration Project.
Archaeological Watching Brief.

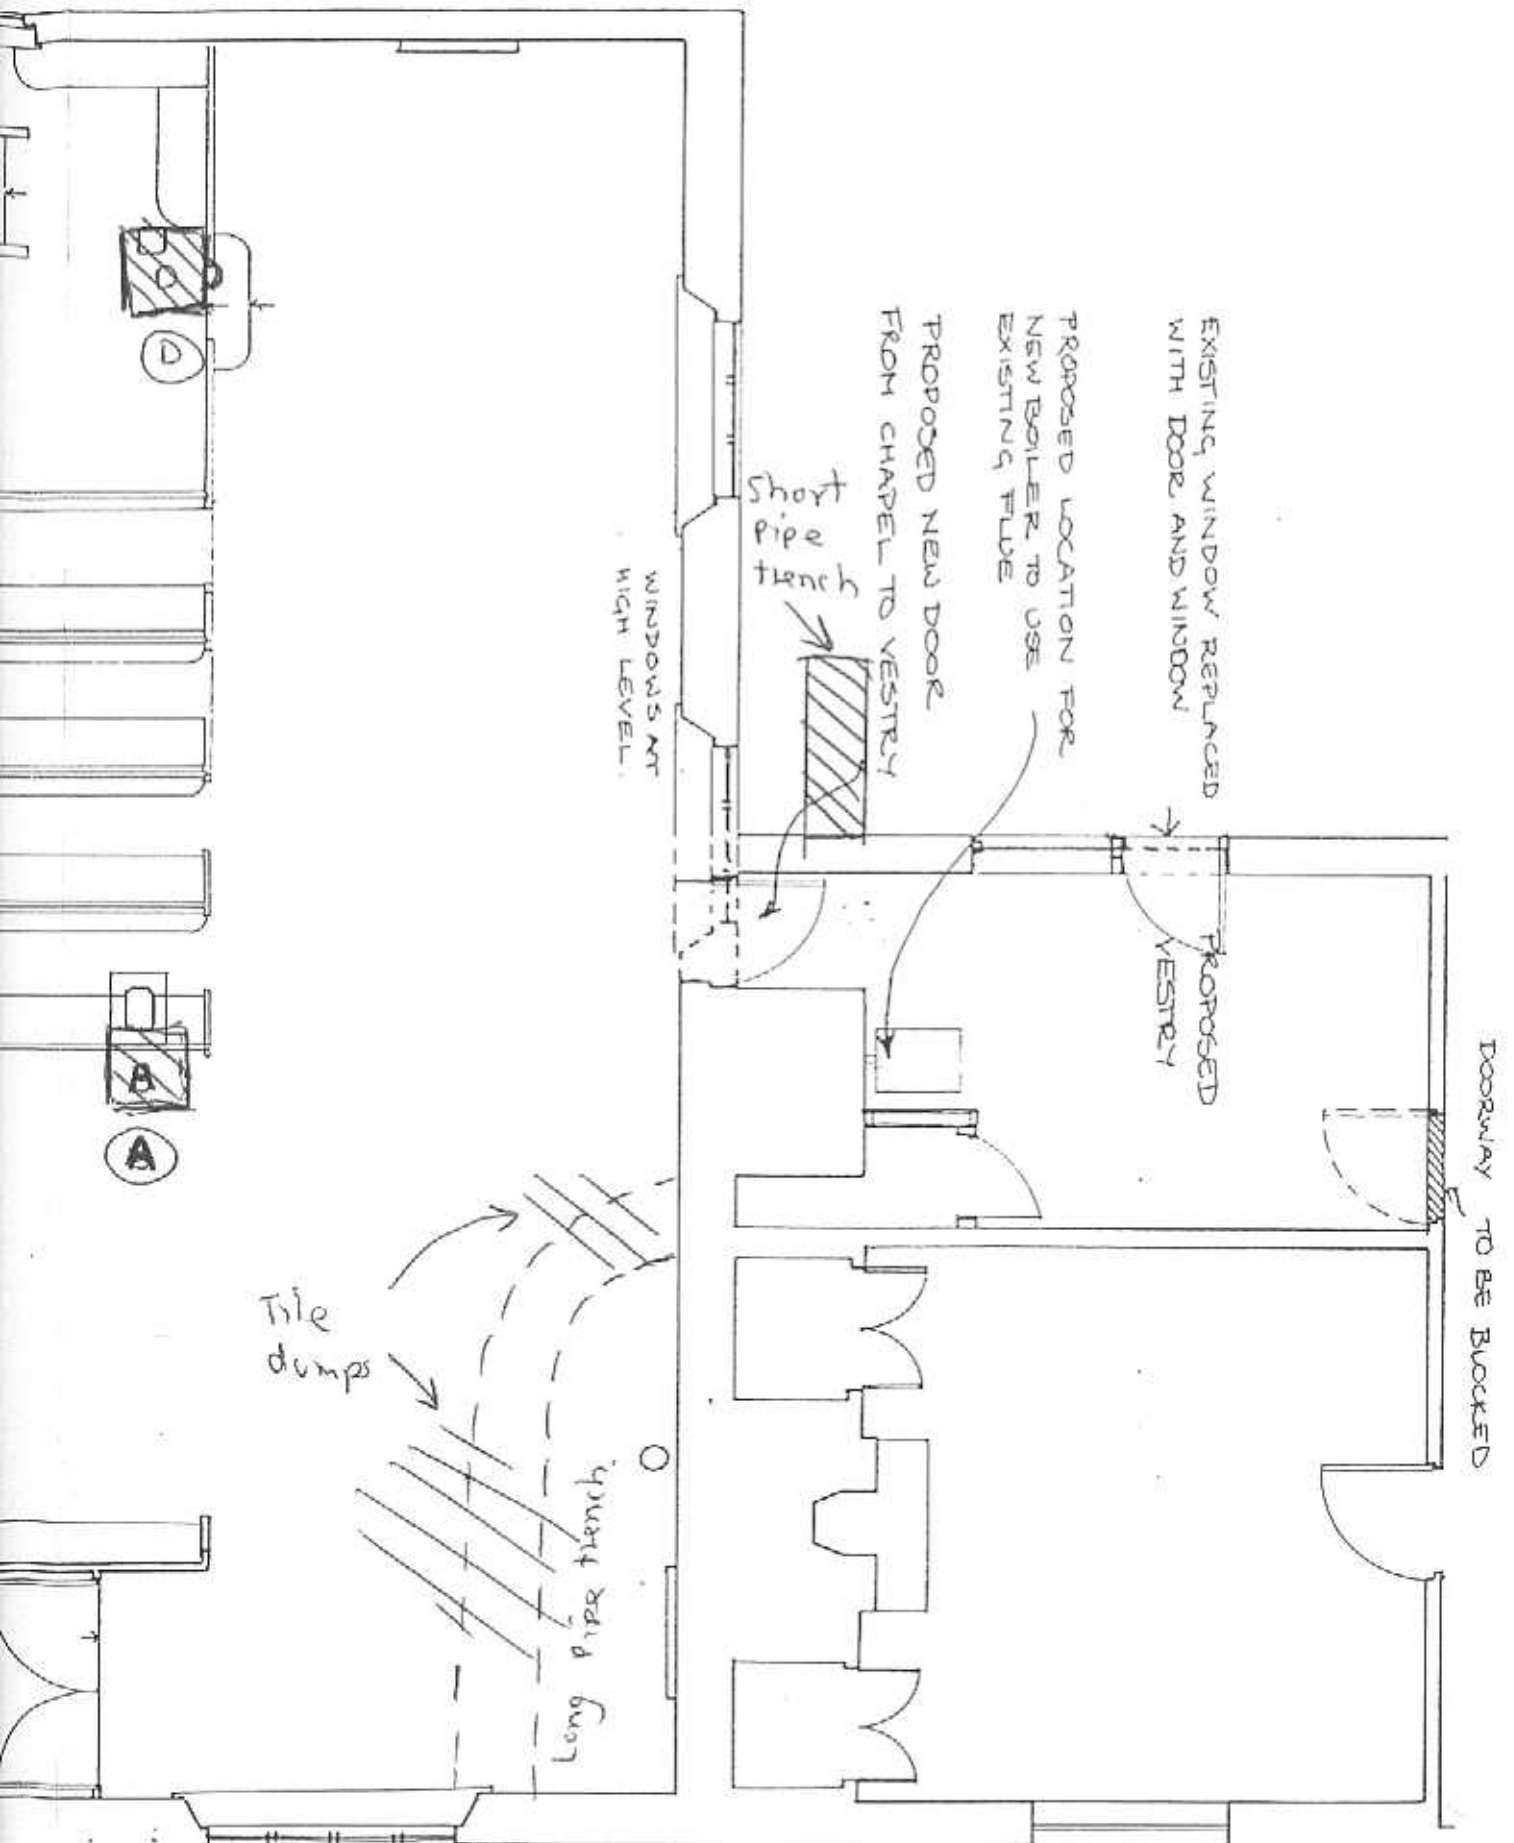
Nothing of archaeological significance was discovered pre-dating Post-Medieval times. The long pipe trench in the south east corner of the chapel, however, did locate tile dumps that pre-dated the construction of the chapel, or to be more precise, the southern wall of the chapel. The tile appeared to be of Medieval or later date but did not accompany any more closely datable finds.

corner of hole B adjacent to a short length of brick wall. Here, this rubble may have been overlain by the gravel layer but this was not clear.

Short pipe trench

Tile dumps

Long pipe trench
