Baynards Park, Cranleigh, Surrey

**An Archaeological Investigation
for Baynards Park Construction Limited**

Site Code BPC04/02

January 2004

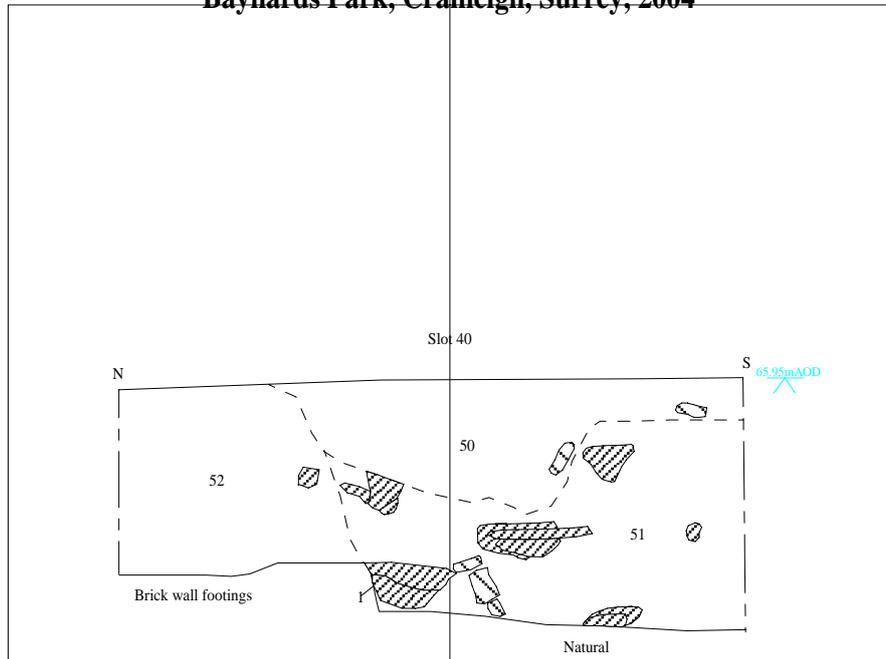
Figure 4. Representative section

A slot (40) (Fig. 4 and Pl. 5) located across the north-western corner of the Elizabethan structure noted that this area of the building had also been severely damaged during demolition. The robbed-out construction cut was fully excavated to the natural clay which was reached at a depth of 0.85m.

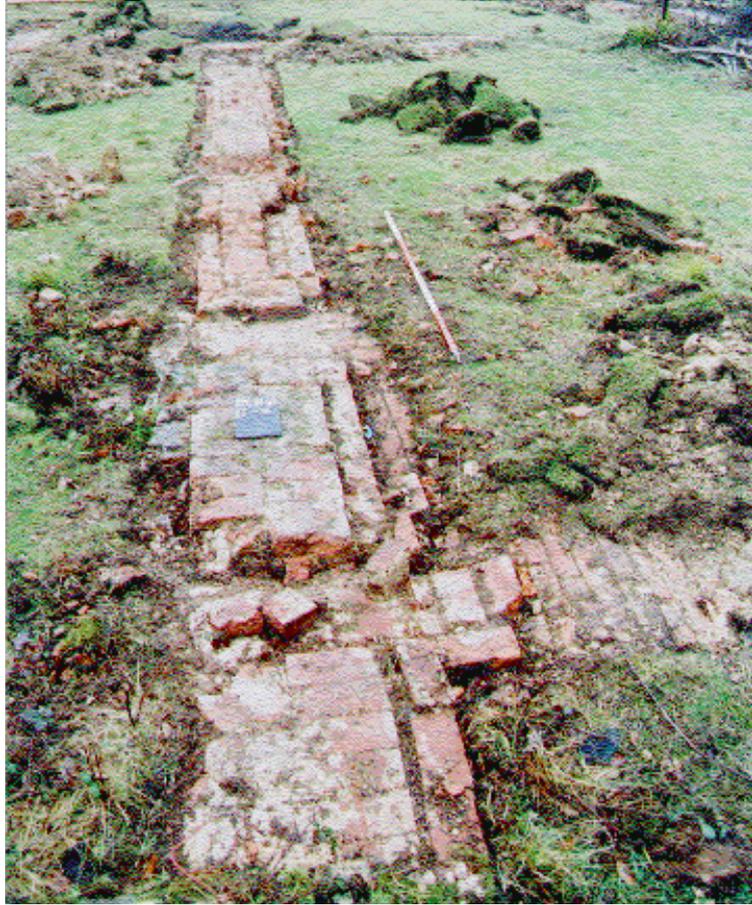
Plate 1. Slot 67. Looking west, scales 2m

Eighty-one trenches, including seven test pits, were hand excavated across the entire site (Fig. 3). Of this number only 25 produced positive walls or footings and all of these were located within the perimeter of the Victorian structure. These were all brick-built footings and in some cases (slots 67 and 71) (Pls 1 and 2) the walls were partially visible just above ground level. In the majority of the slots containing walls/footings, the structures only became visible below approximately 0.10–0.15m of turf and between 0.05m–0.70m of demolition rubble.

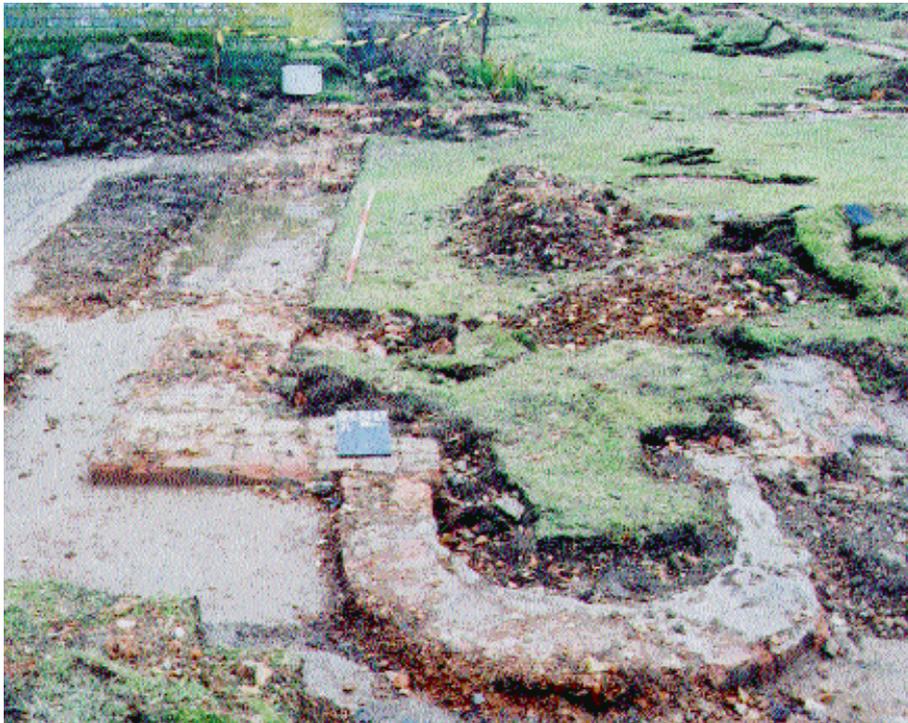
Plate 2. Slot 71. Looking east, scales 2m

Slot 71 (Pl. 2) excavated across a segment of the Victorian structure on the northern face of the building, identified not only brick footings but also several exterior features. A solid concrete slab followed the lines of the footings and according to the ground floor plan lay outside the main structure. Also in this slot a semi-circular brick-built feature was noted which butted up against the exterior of the building. This had an internal diameter of approximately 1.00m; its function is unclear.

<i>Trench No.</i>	<i>Depth (m)</i>	<i>Comment</i>
65	0.15m	0.10m turf; 0.05m demolition rubble removed to possible wall, heavily truncated. No natural encountered.
66	0.15m	0.10m turf, 0.05m demolition rubble overlying further rubble. No natural encountered.
67	0.10m	0.10m turf removed to reveal roughly t-shaped stretch of wall 11m east west and 7m north south. [Plate 1]
68	0.44	0.18m turf; 0.24m demolition rubble removed to reveal L-shaped brick footing.
69	1m	0.10m turf, overlying 0.90 demolition rubble removed to reveal possible construction cut however very heavily disturbed. [Plate 4]
70	0.05m	0.05m turf removed to reveal brick footings aligned east west and part of flagstone flooring.
71	0.10m	0.10m turf removed to reveal brick footings aligned east west. Concrete base uncovered which would have been associated with the exterior of the building. A semi circular brick built structure, also an exterior feature was identified. [Plate 2]

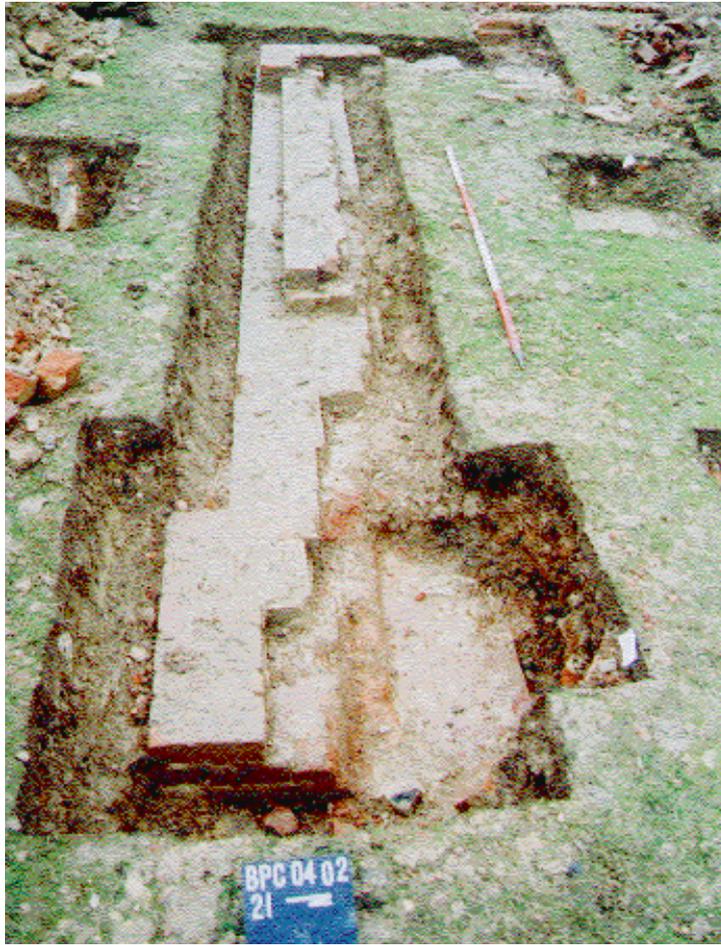
Plate 3. Slot 21. Looking west, scale 2m

Of note is slot 21 (Pl. 3) in which a wall was recorded, approximately 5.5m in length, aligned east-west with a return at the western end. This slot was located within the Victorian structure but was not recorded on the

ground plan provided. It is unclear what the function of this wall was but due to its similarity in style to the surrounding walls it was assumed to be contemporary with the Victorian building.

13	0.20m	0.10m of turf; 0.10m demolition rubble removed to reveal possible wall very truncated
14	0.34m	0.10m of turf; 0.24m demolition rubble, overlying further demolition rubble. Natural was not encountered.
15	0.14m	0.10m turf; 0.04m demolition rubble removed to reveal 0.60m of brick drain orientated north-south
16	0.40m	0.10m of turf; 0.30m of demolition rubble, overlying further demolition rubble. Natural was not encountered.
17	0.33m	0.10m of turf; 0.23m of demolition rubble, overlying further demolition rubble. Natural was not encountered.
18	0.20m	0.10m of turf; 0.10m of demolition rubble overlying further demolition. Natural was not encountered.
19	0.20m	0.10m turf; 0.10m demolition rubble, overlying further demolition rubble. Natural was not encountered.
20	0.20m	0.10m turf; 0.10m demolition rubble, overlying further demolition rubble. Natural was not encountered.
21	0.40m e end 0.10m w end	0.10m turf, 0.30m demolition rubble removed to reveal L-shaped segment of brick wall footings 5.5m aligned east west and 2.5m aligned north-south. This wall does not relate to any recorded on the ground floor plan supplied by the client. [Plate 3]

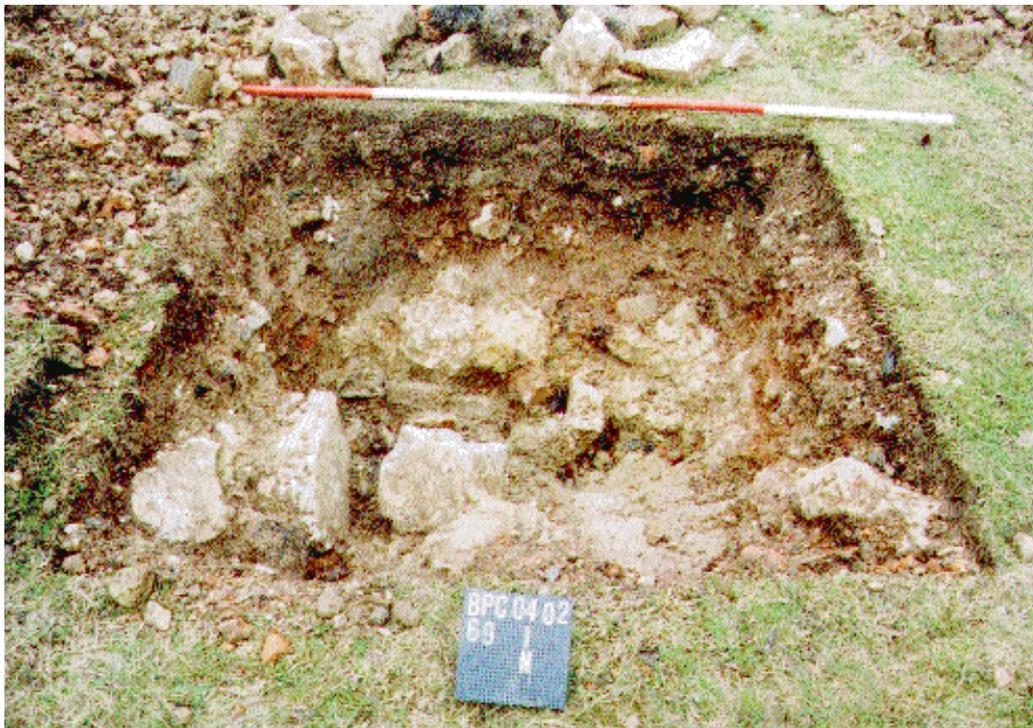
Plate 4. Slot 69. Looking south, scale 2m

Within the perimeters of the Elizabethan house very little appeared to survive the demolition. Slot 43, which was excavated across the western side of the entrance way on the northern face of the building, revealed a construction cut surviving at approximately 0.40m below the turf. The slot (69) (Pl. 4) excavated across the opposite side of the entrance way however did not reveal a construction cut. Instead this contained several large chalk blocks, none of which were *in situ*. The slot was excavated to a depth of approximately 1m and had clearly been robbed out.

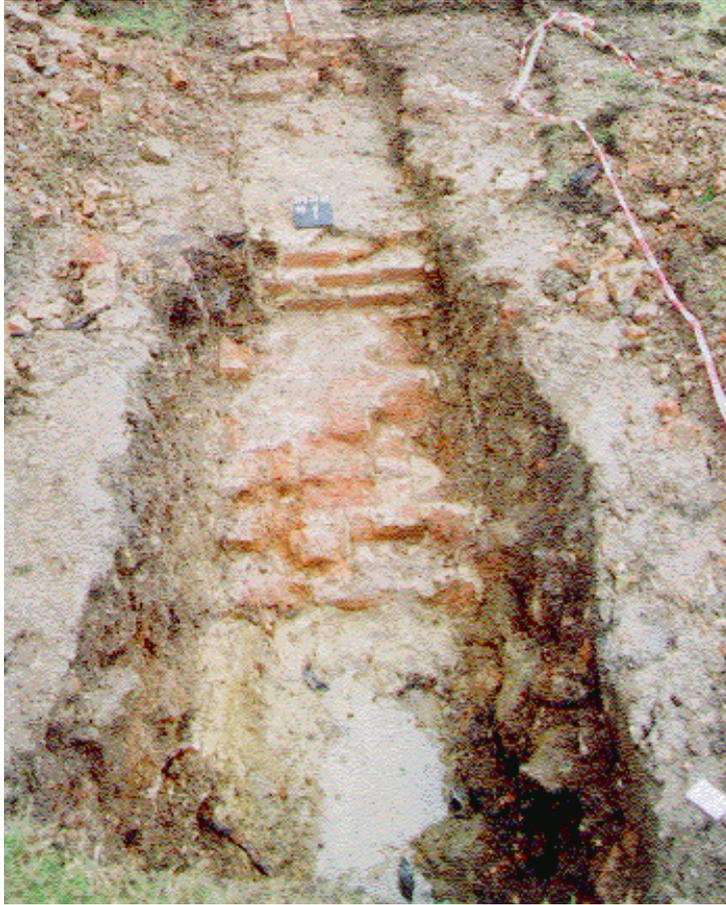
Plate 5. Slot 40/TP 5. Looking north, scale 2m

This was located at the north-western corner of the Elizabethan building. 0.10m of turf was removed to reveal 0.75m of rubble which filled the robbed out construction cut for the wall. The natural clay was recorded at a depth of 0.85m.

40/TP5	0.95m s end	0.10m turf; 0.85m demolition rubble removed to reveal natural clay. This slot contained the continuation of the garden wall aligned north south which butted up to the original Elizabethan building. Brick footings became heavily truncated towards the south. [Plate 5]
41	0.60m	0.10mturf; 0.50m demolition rubble overlying further rubble. No natural was encountered.
42	0.65m	0.10m turf; 0.55 demolition rubble, overlying further rubble. No natural encountered.
43	0.40m	0.10m turf; 0.30m demolition rubble removed to reveal sandy mortar and chalk block filling construction cut. Natural encountered at 0.30m
44	0.40m	0.10m turf; 0.30m demolition rubble. Construction cut visible aligned north south. No natural encountered
45	0.30m	0.10m turf; 0.20m demolition rubble removed to reveal a stone filled construction cut (robbed out).
46	0.10m	0.10m turf removed to reveal small section of stone wall aligned north south and 2m of brick wall aligned east-west. No natural encountered.

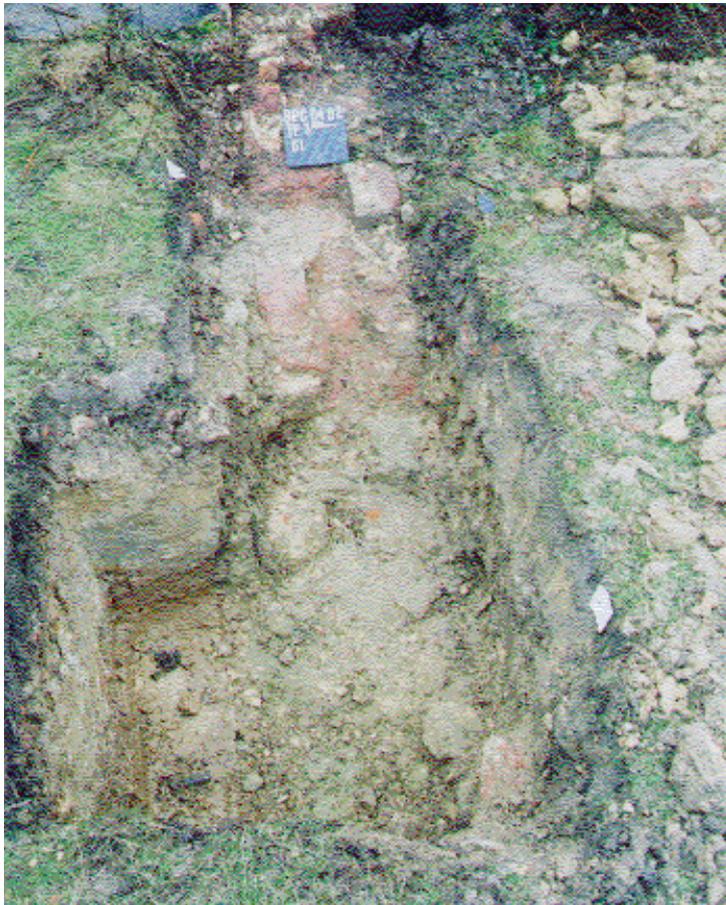
Plate 6. Test Pit 3/Slot 61. Looking east

This was located on the eastern boundary of site. Natural clay was recorded immediately below the turf on the northern side of the slot. A robbed out construction cut was identified on the southern edge of the test pit, this was excavated to a depth of 0.67m, but was not bottomed.

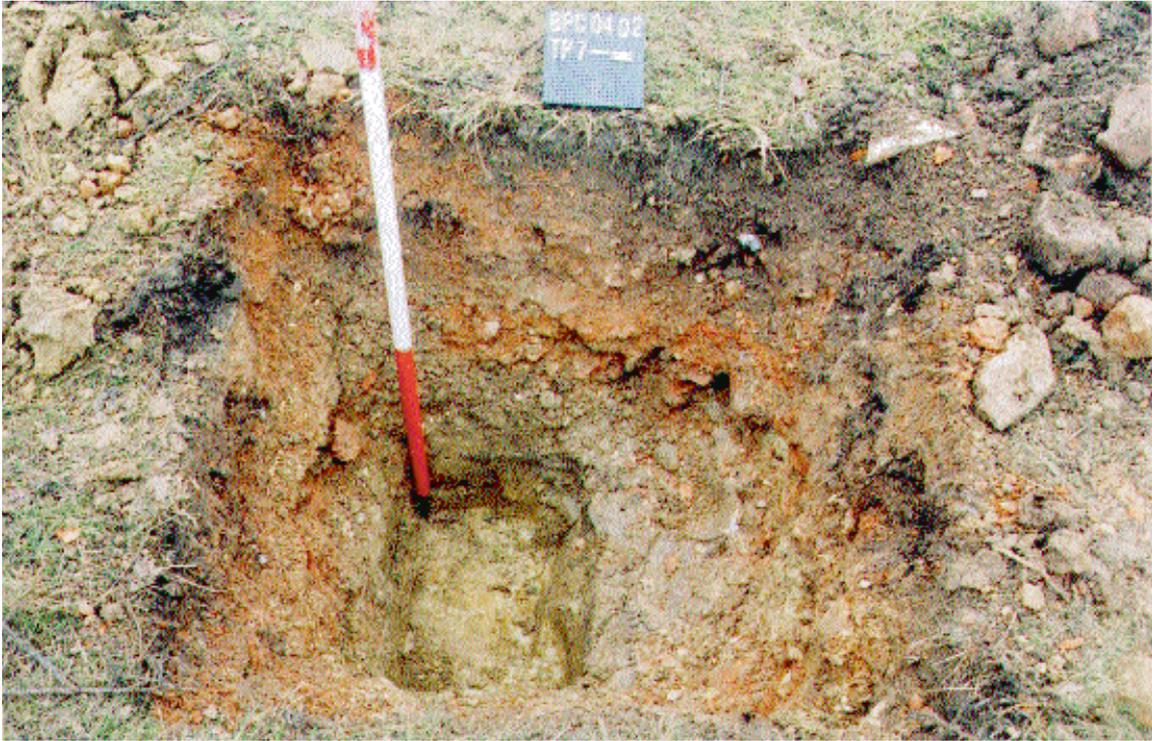
Plate 7. Test pit 7. Looking west, scale 2m

This was situated just beyond the boundaries of the building in the south-western corner of the site. 0.20m of turf was removed to reveal 0.33m of demolition rubble, which in turn overlay 0.27m of redeposited clay, the natural clay was encountered at 0.80m.

81/TP7	0.80m	0.20m turf; 0.33m demolition rubble overlying 0.27m redeposited clay. Natural clay was encountered below the redeposited clay. [Plate 7]
