**Anti-Aircraft Defence Tower, Mill Lane,  
Byfleet, Surrey**

**Building Recording  
For Rectory Homes Ltd**

Site Code MLB 05/100

**February 2006**

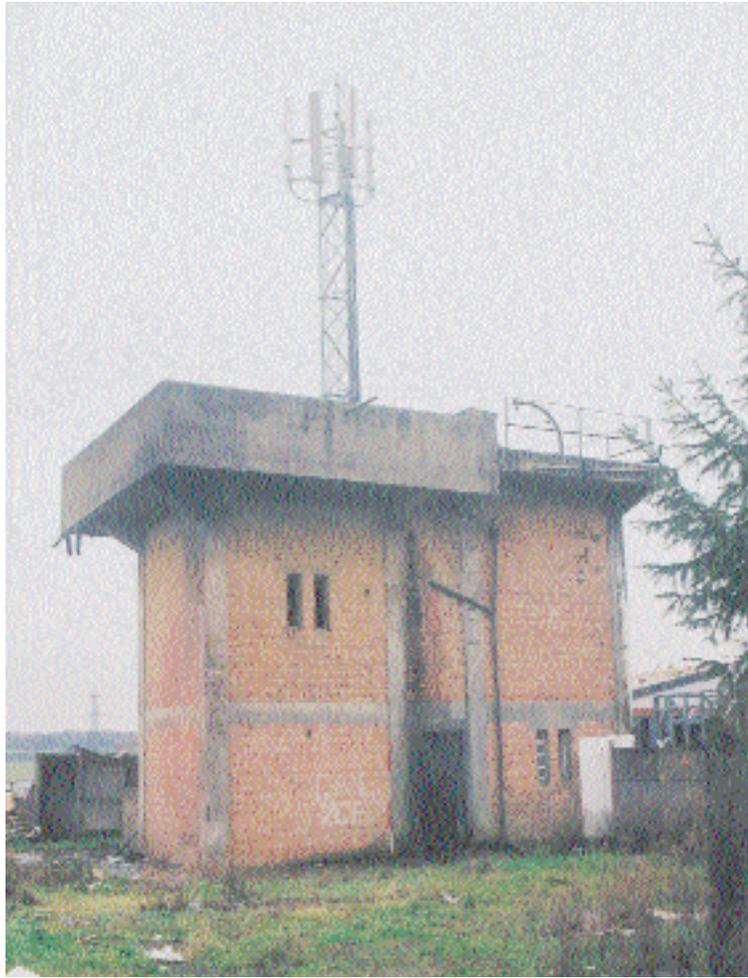
Plate 1. North elevation of tower, scale 2m.

The building on the site at Mill Lane is a two-storey structure of reinforced concrete and bricks (Pl. 1). The building was constructed in one phase with reinforced concrete forming the main frame and the bricks creating an infill. The roof is concrete and is at two levels, with a difference in thickness between the two sides.

The tower at Manor Farm is of a simple structure that would enable its construction within a short space of time. The main frame of the building was constructed in concrete with brick infill (Pl. 1). The windows are narrow both which provides an ideal defensive position and also reduces the amount of light emitted during times of blackout. Gun positions often began as field stations with simple huts or tents to accommodate operators, later replaced by more permanent concrete structures, although these were more usually sunken into the ground. It is probable that this tower was constructed around the same time as that at Brooklands and in a similar style.

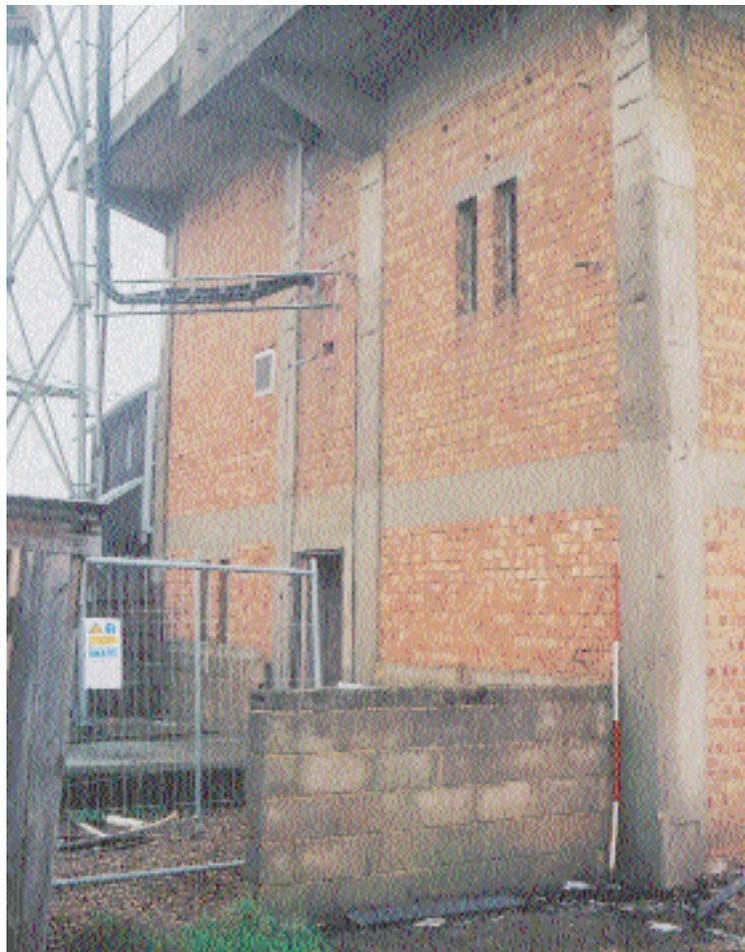
Plate 2. South elevation of tower, scale 2m.

At ground floor level, a breeze block wall 5½ blocks high, butts the south wall along the entire face of the building, respecting the central doorway. It also extends 2.45m long at a 90 degree angle at each end of the elevation, (Pl. 2). There are scars for two further walls which would have extended from the building at each side of the central doorway which would have created two enclosed bays. The wall obscures the concrete sills of the windows at ground floor level suggesting it was not part of the original build.

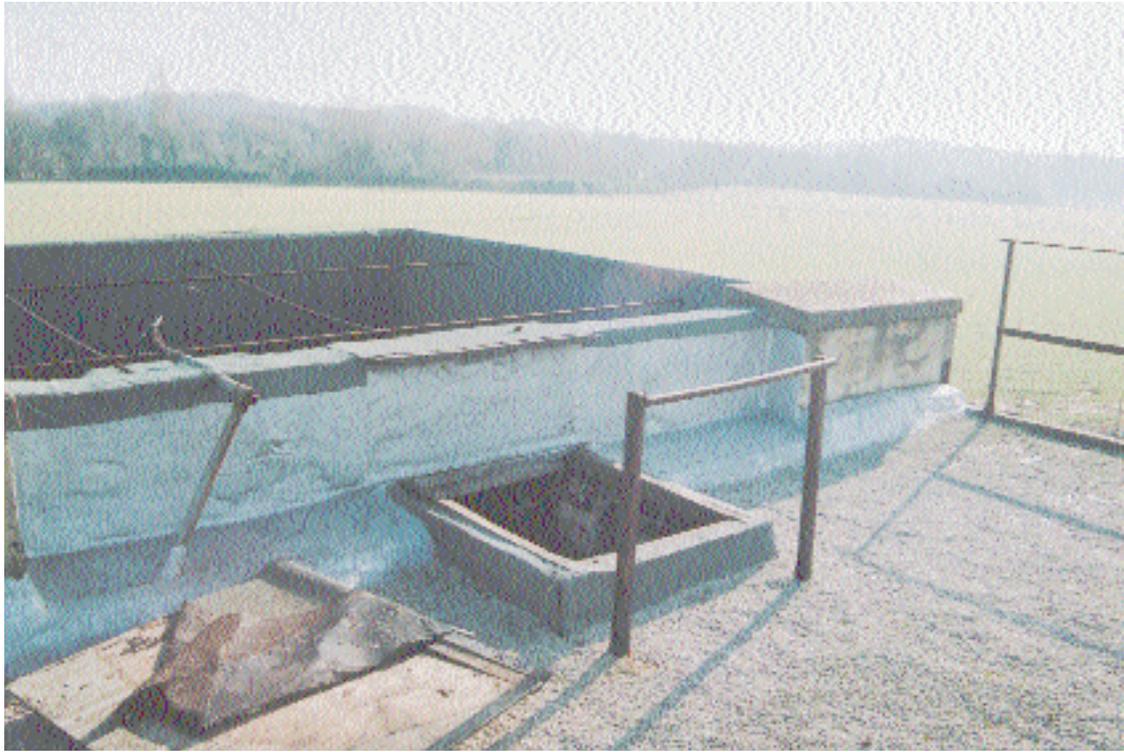
Plate 5. Roof of tower; hatch opening with railing and pipe.

The roof is surfaced in both green felt and gravel. The roof hatch is located just to the western side of the centre of the roof, adjacent to a brick wall with a concrete cap which divides the roof into two separate spaces (Pl. 5). The brick wall is approximately 0.60m high, its top level with a felt covered concrete retaining wall approximately 1.10m high around the lower (eastern) portion of the roof. The roof hatch has a metal safety railing. A second railing is situated around the edge of the roof on three sides of the western portion, and a hoist

The metal pipe that appears at the roof surface and is directed over the mid wall could not be traced within the interior of the tower but it is possible that this pipe brought water to the roof (Pl. 5). It may be not be contemporary with the original use of the tower.

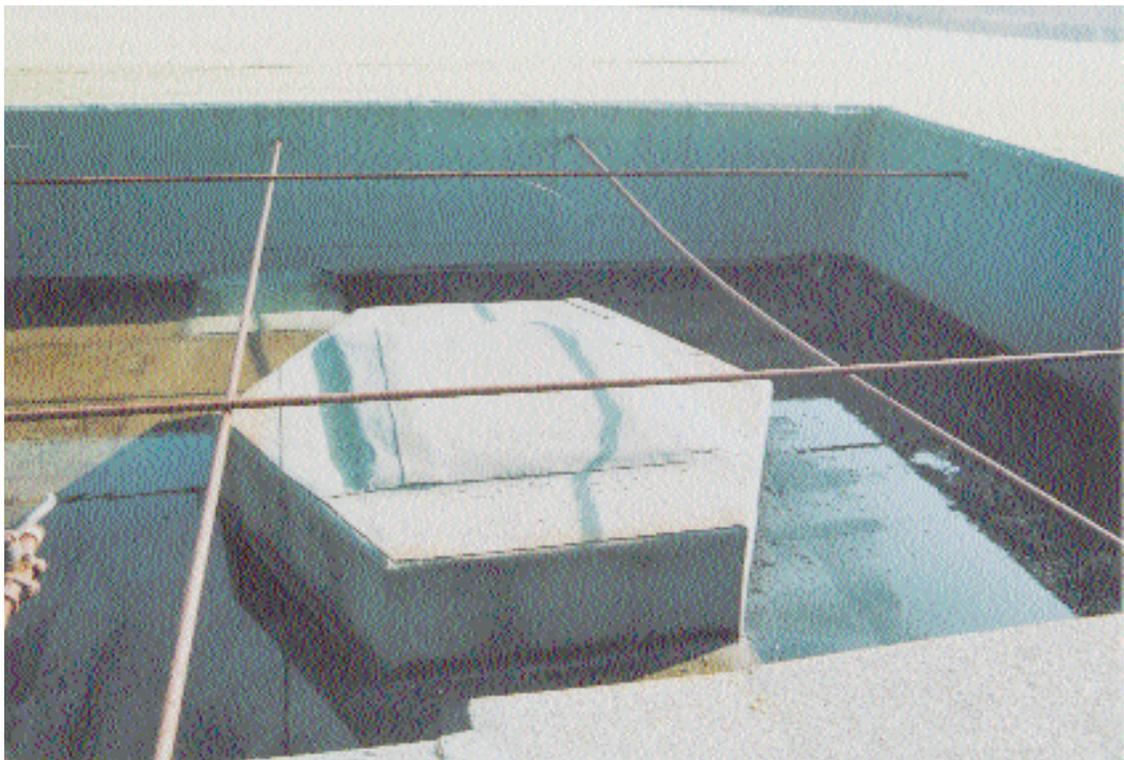
Plate 6. Roof of tower; hexagonal mount with central raised square and metal grid.

In the centre of the eastern roof space was a concrete hexagonal platform, with a square platform centrally placed on top of it, covered in roof felt. A grid of metal bars is positioned across it and fastened into the surrounding concrete walls (Pl. 6).

The metal grid placed at mid height on the lower portion of the tower would have restricted movement within this space and around the gun platform itself and is therefore also thought to be a secondary feature (Pl. 6). The metalwork does however appear contemporary with the railings and other fixtures on the roof and it can therefore not be ruled out that it may be contemporary with the structure although its function is unknown.
