Former British Telecom Site,
Willow Road,
New Malden

An Archaeological Evaluation

Former British Telecom Site, Willow Road, New Malden
Archaeological Evaluation

Project 95/30

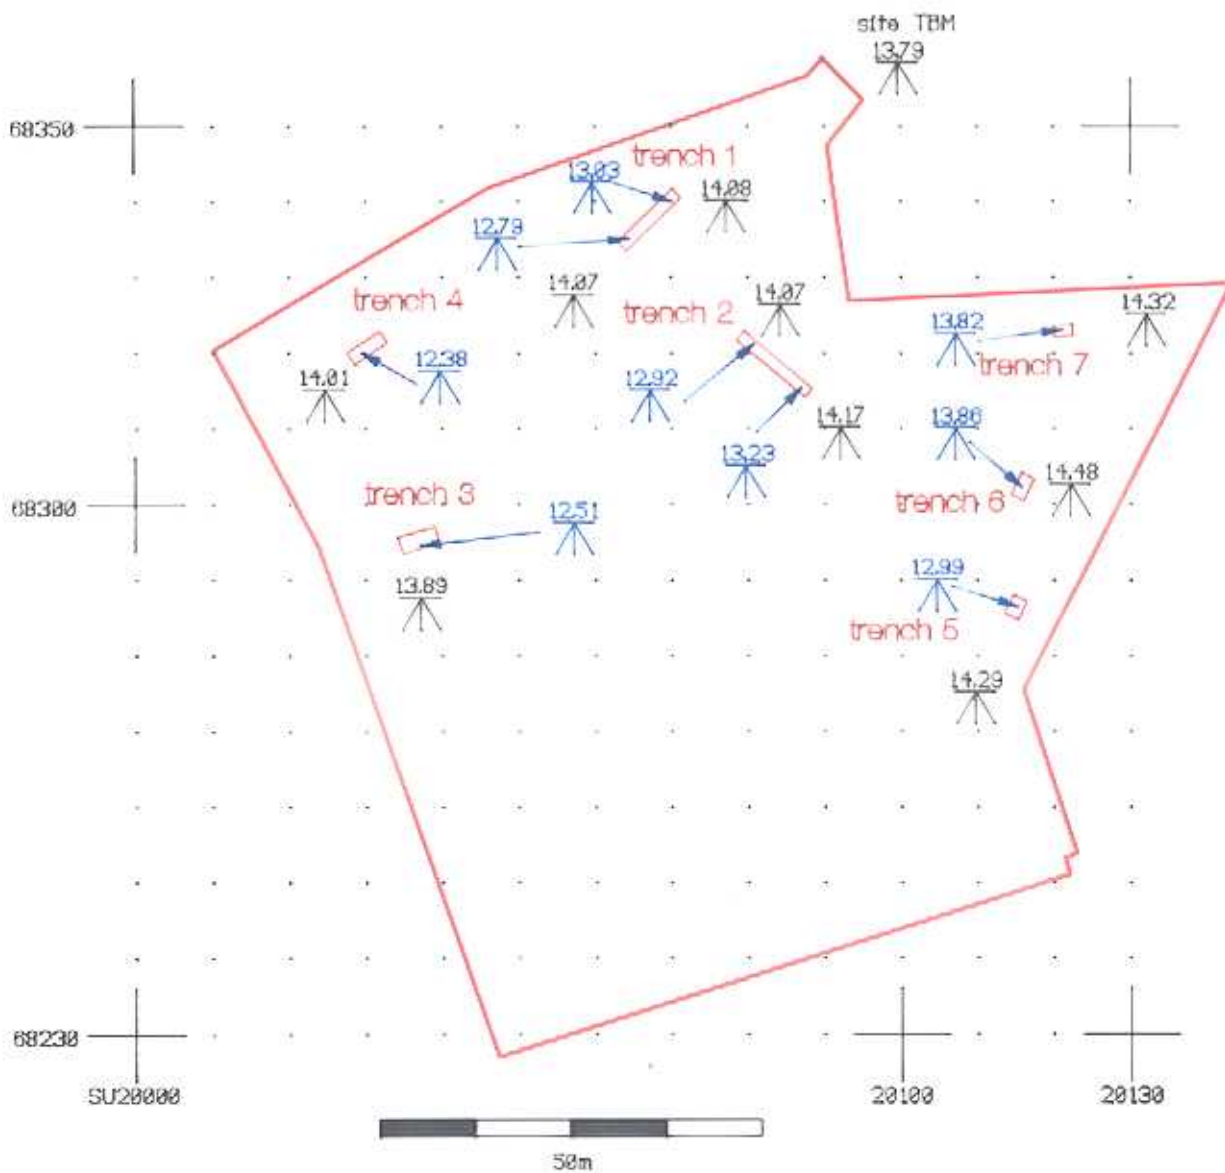
Figure 3. General location of site and trenches.

A total of seven trenches were dug by a JCB fitted with a toothless ditching bucket (a toothed bucket was used in some trenches to remove building rubble from upper layers) exposing 75 sq. m. of natural geological surface (Figs. 2 and 3). Sections of each trench can be seen in Figure 4 and descriptions of stratigraphy in Appendix 1.

all heights are in metres above OD
heights in blue are trench depths

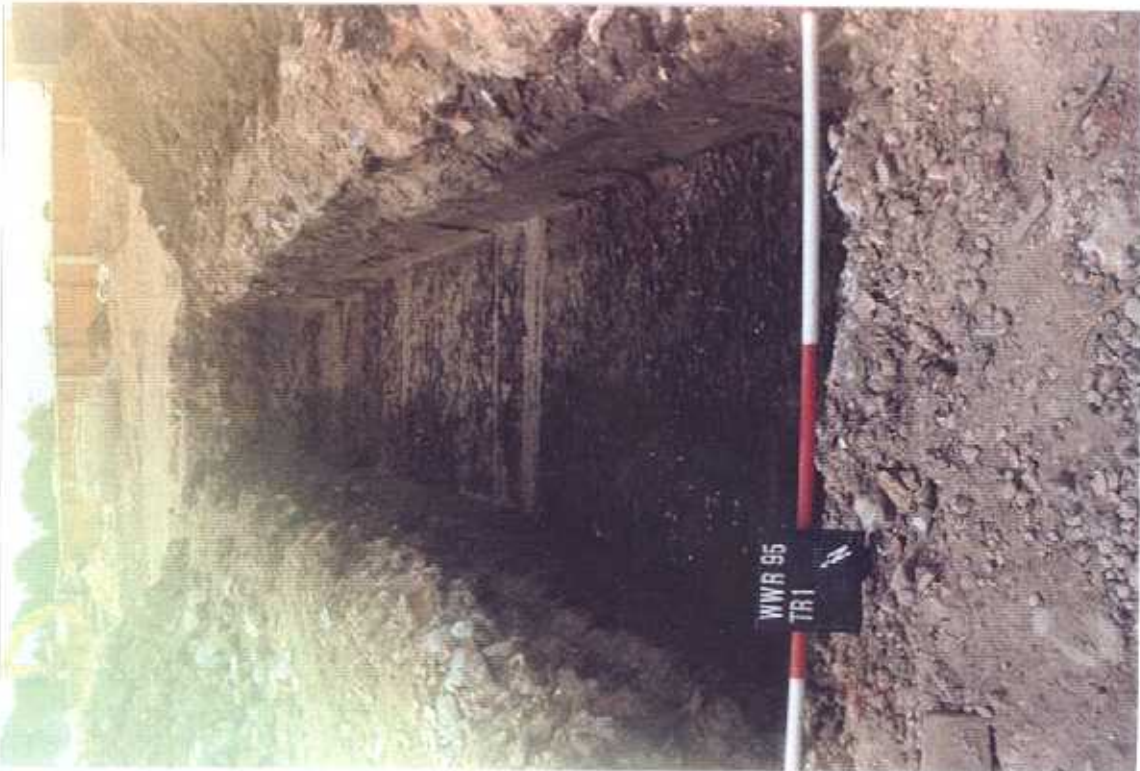
In three of the trenches (1, 3 and 4) a black clay mixed with some building rubble was present underneath the layer of rubble that overlay the whole site. In two cases a green silty clay layer, thought to be contaminated, was below the black clay and overlying an orange/brown clay natural. In the third case the black clay overlay blue/grey clay natural (trench 3).

Plate 1. View of trench 1 looking south.

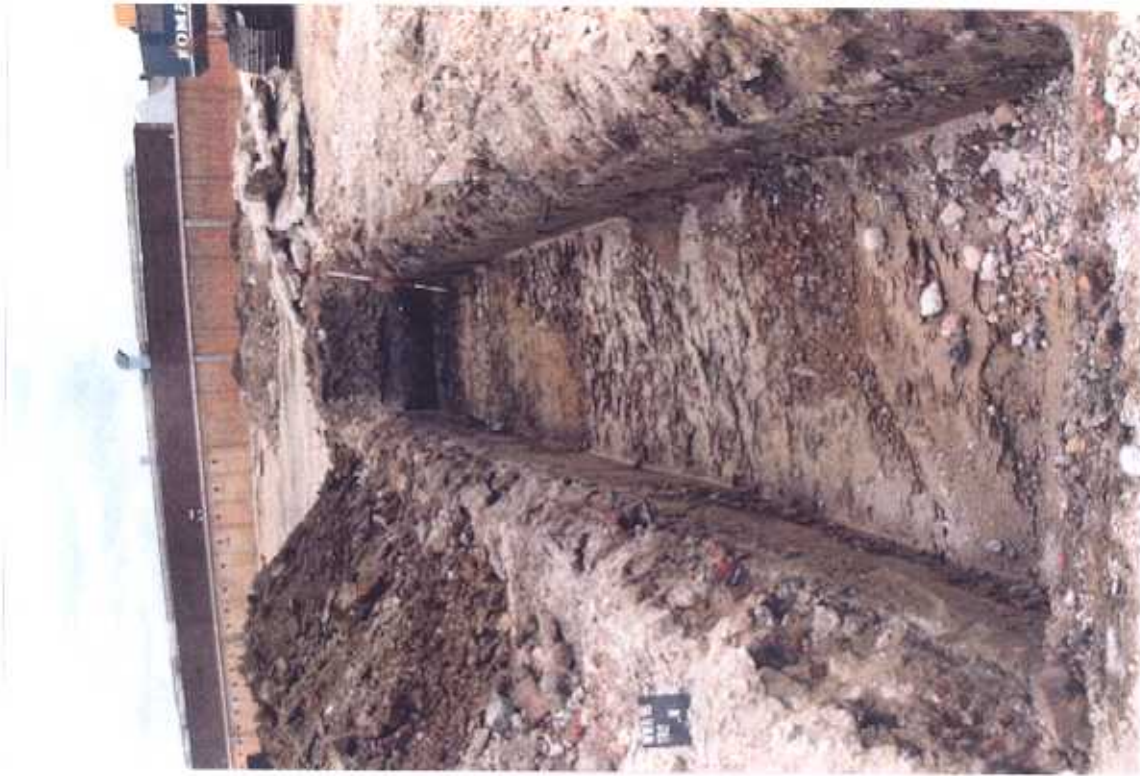
Three trenches in the north-eastern section of the site proved much shallower than the rest at less than a metre deep; trench 2 consisted of rubble over green silty clay above dirty brown/orange clay with an orange/brown natural base, trench 6 consisted of building rubble over orange clay natural and trench 7 was similar with a dirty orange/brown layer of clay over the brighter orange clay natural.

Plate 2. View of trench 2 looking north west.

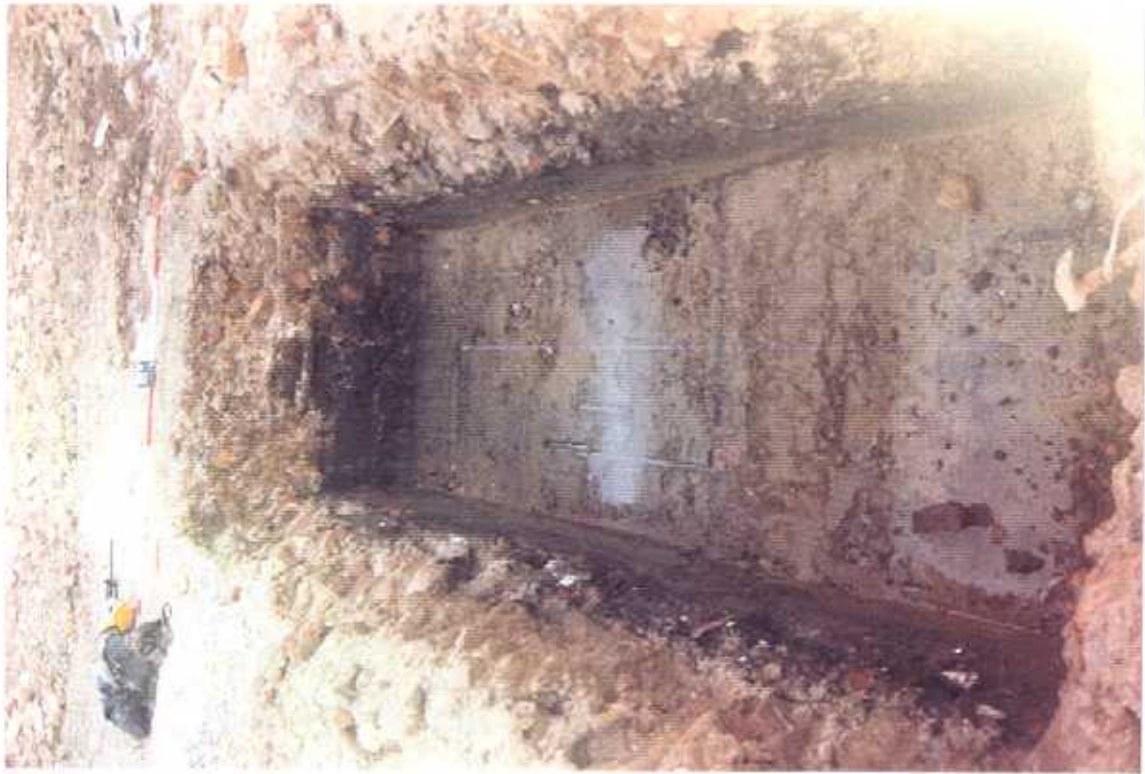
Plate 3. Trench 3 looking north.

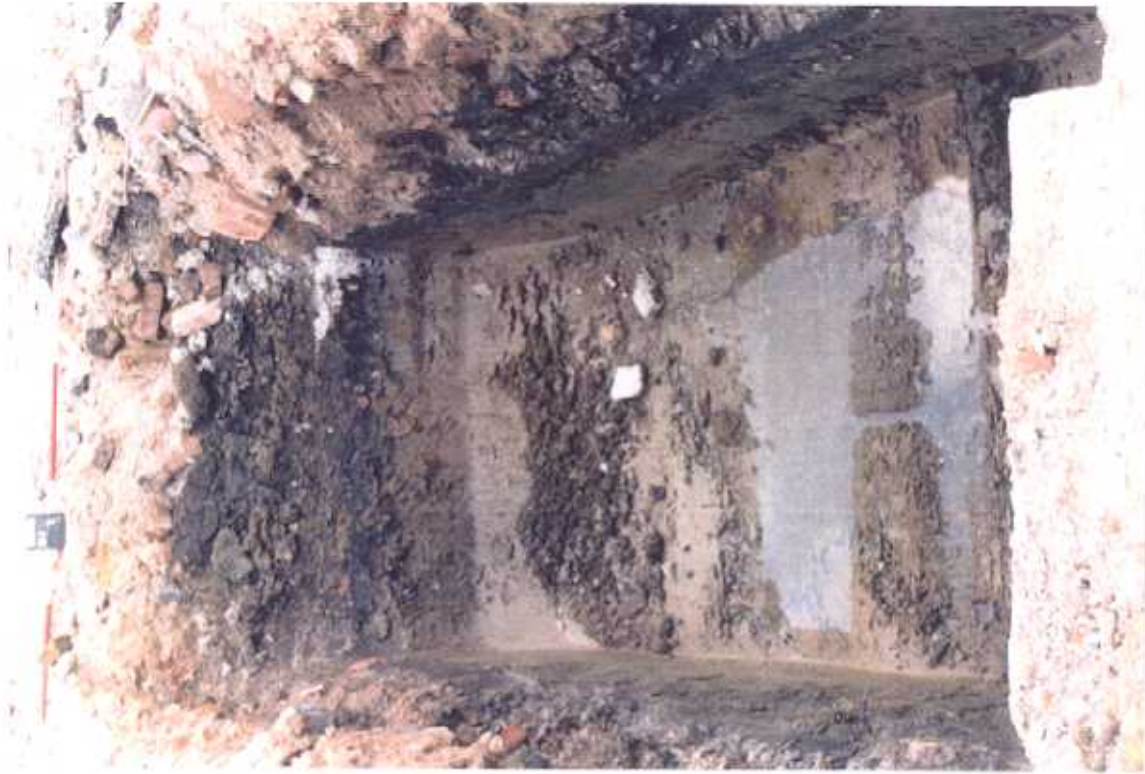
Plate 4. Trench 4 viewed from the south.

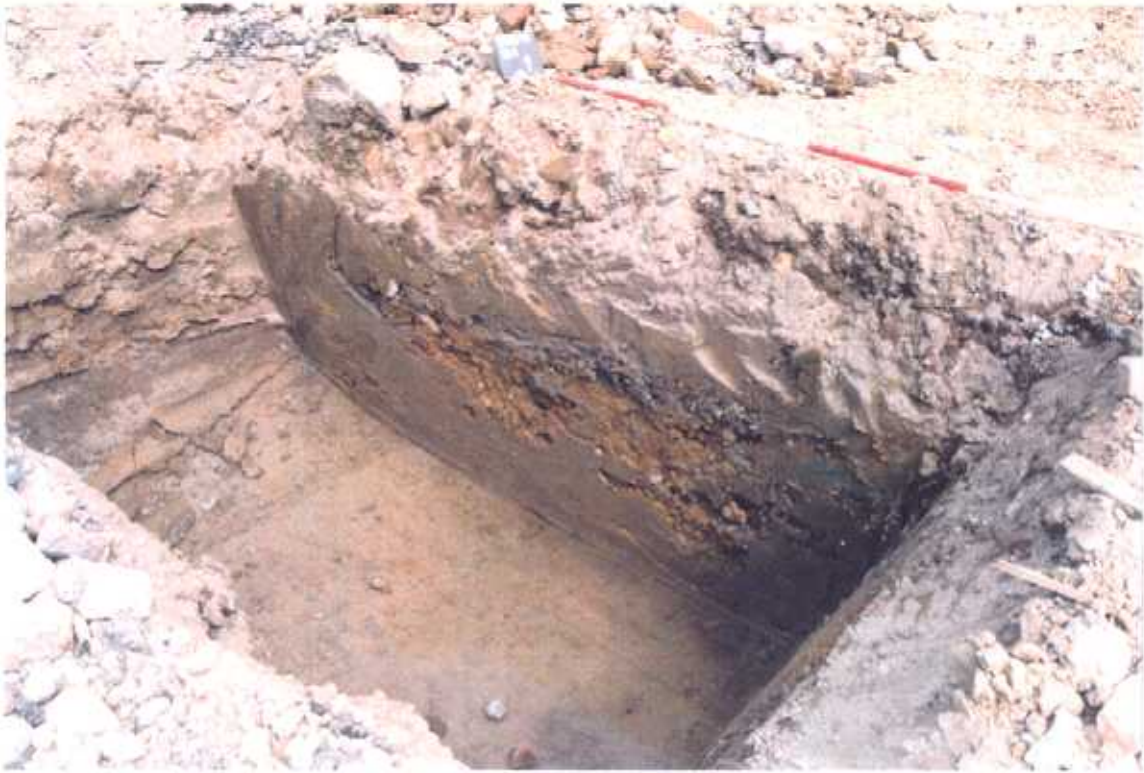
Clay that appeared to be redeposited was found in trench 5 where it seemed to surround a lens of grey gravel over a gravel and sand mix. A cleaner grey/orange clay was encountered below this.

Plate 5. Trench 5 viewed from the south.

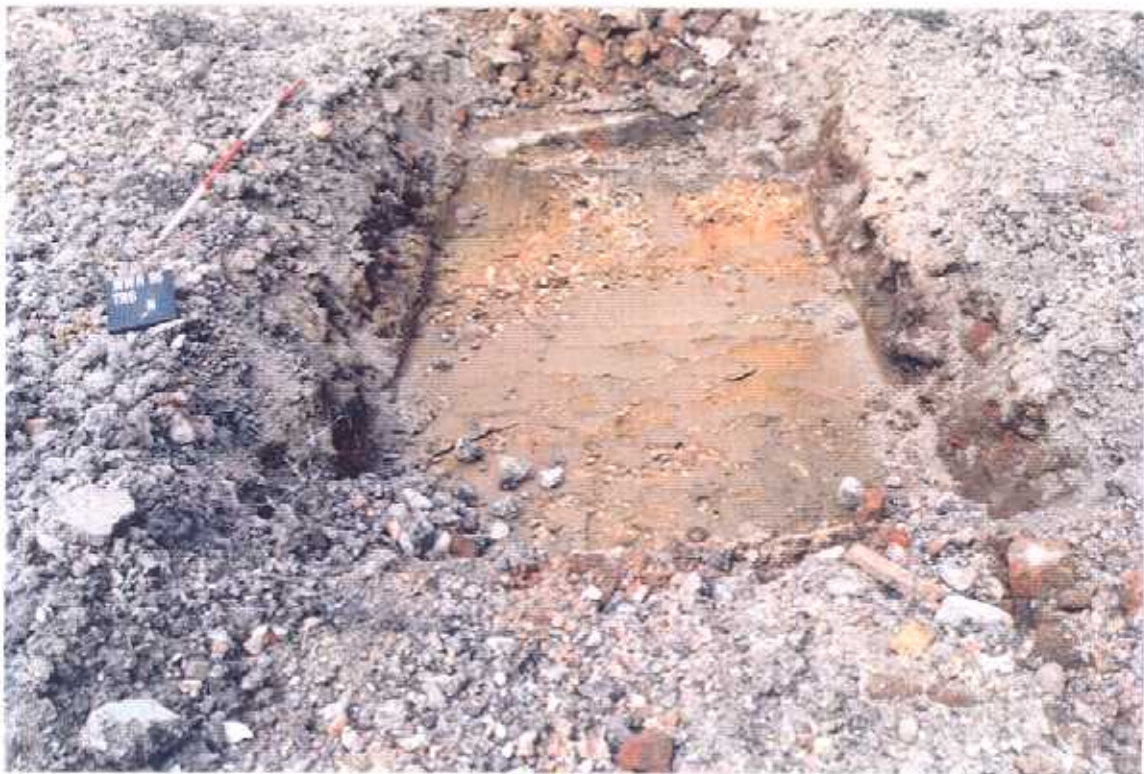
Plate 6. View of trench 6 from the east.

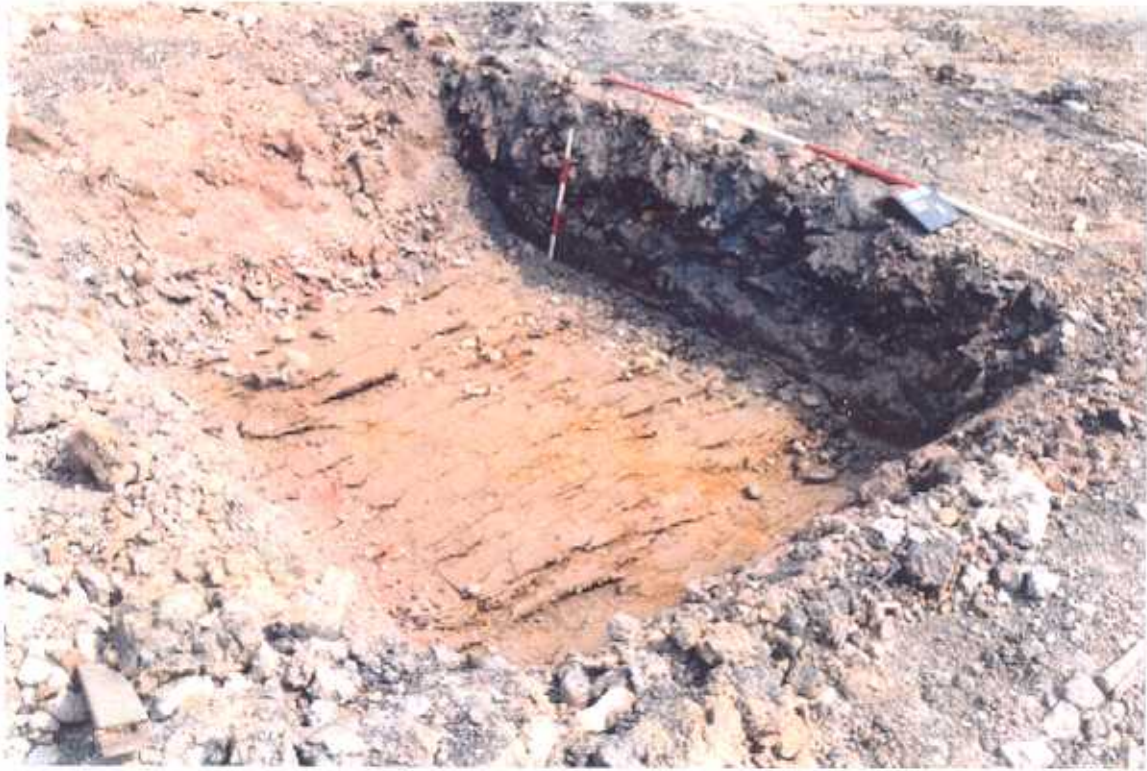
Plate 7. View of trench 7 from the south west.
