**The Masonic Centre,
Goldsmiths Lane, Wallingford, Oxfordshire**

**An Archaeological Watching Brief
for Wallingford Masonic Centre Ltd**

Site Code MCW99/31

Report 99/31

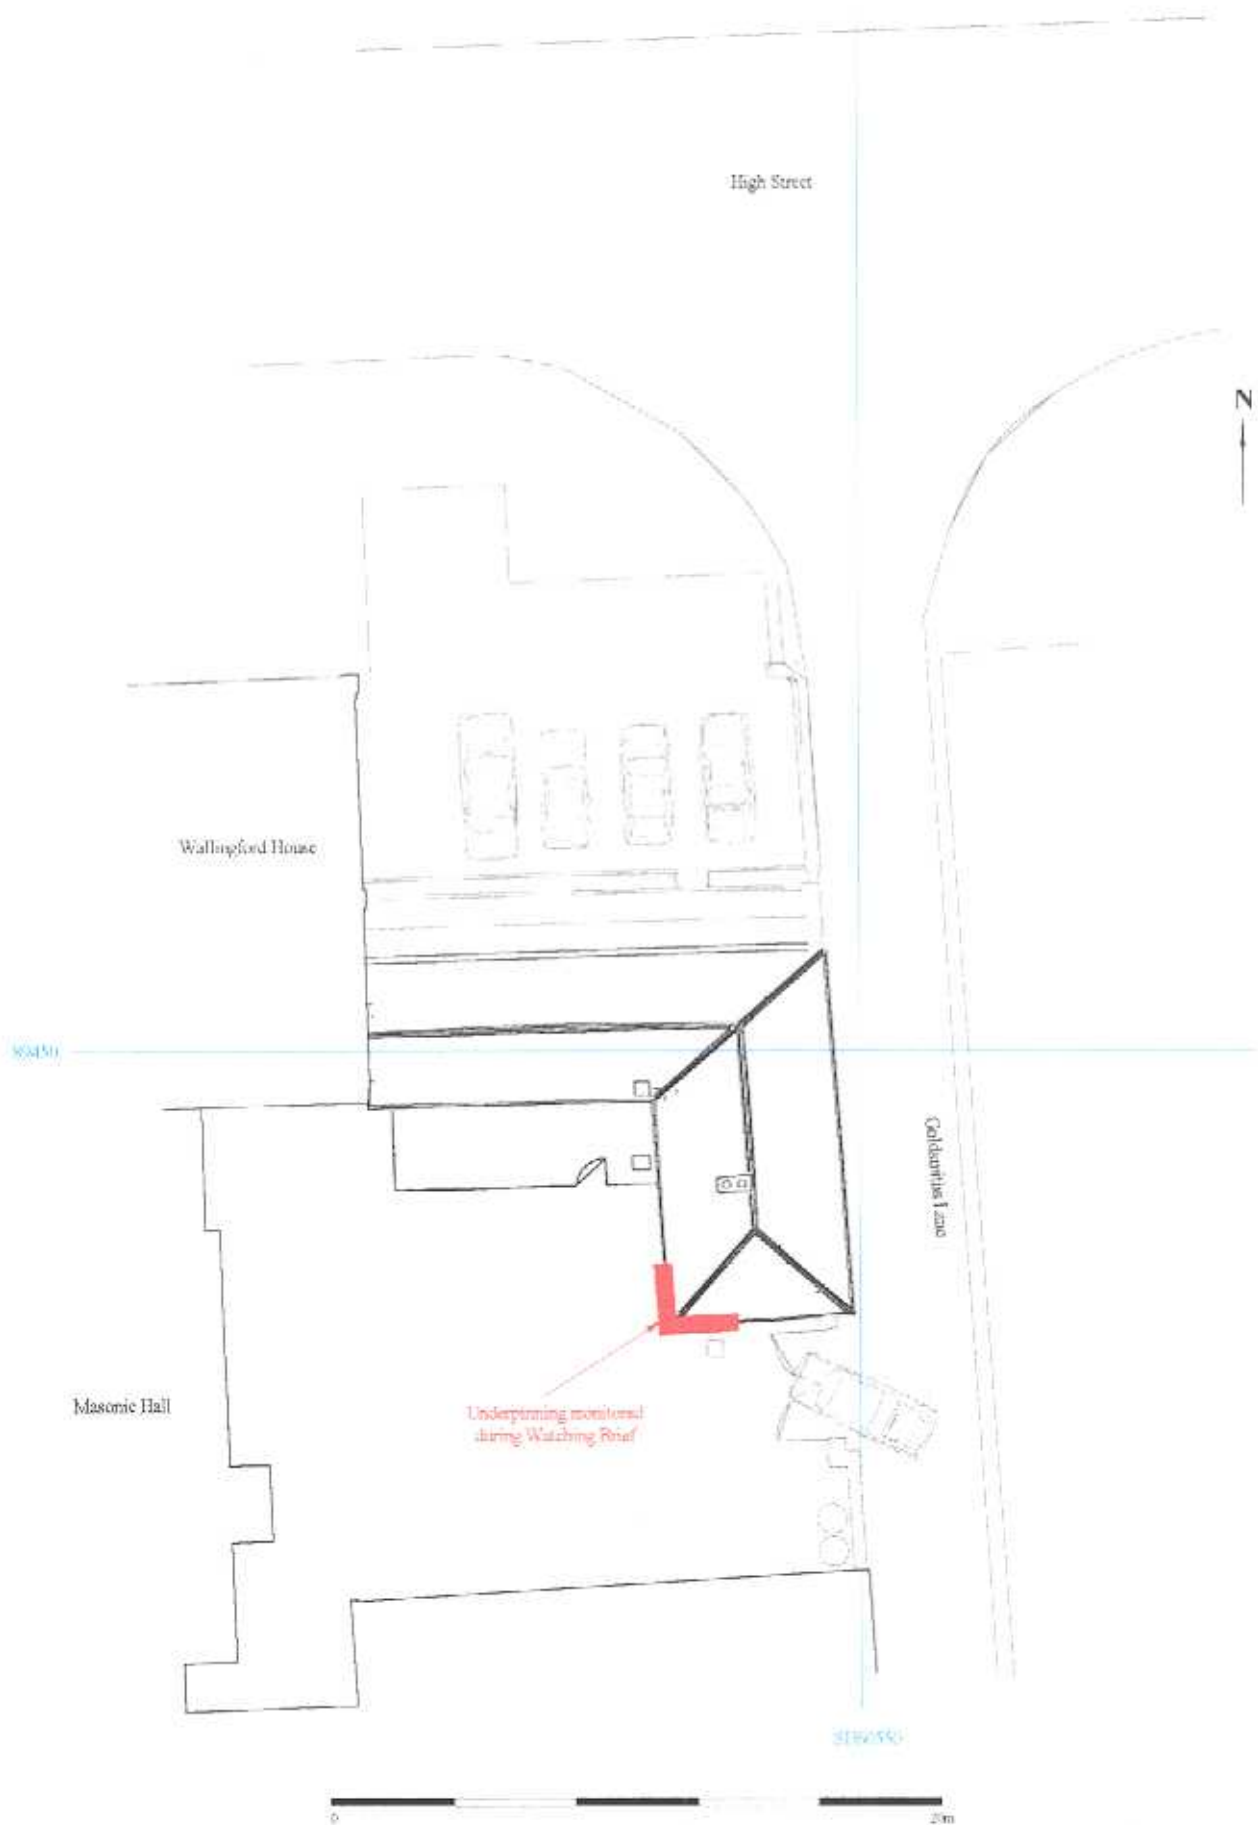
Figure 3 Location of underpinning

The site lies to the west of Goldsmiths Lane at its northern junction with the High Street, Wallingford (Figs 2 and 3). The standing building examined was probably a stable block constructed in the late 18th century. It had evidence of a hay loft and overlooked a yard to the rear of the Masonic Hall. An 18th century servants block was sited between the stables and the house. The underpinning was located at the south-west corner of the former stables (Fig 3).

The excavation of the slot for underpinning was conducted in two stages. The slot was 3.5 m long, in an 'L' shape, and 0.5 m wide. At its deepest it was 0.8 m below the modern ground surface. A homogenous buried loamy garden soil was observed in the slot. No cut features were seen. Pottery fragments, brick pieces and clay pipe stems (not retained) indicated a late 18th century deposition date. This deposit stratigraphically predated the building but was clearly deposited (perhaps as household refuse) towards the end of the 18th century.
