**Chantry Street,  
Andover, Hampshire**

An Archaeological Evaluation

Site Code  
CSA99/41

Report 99/41

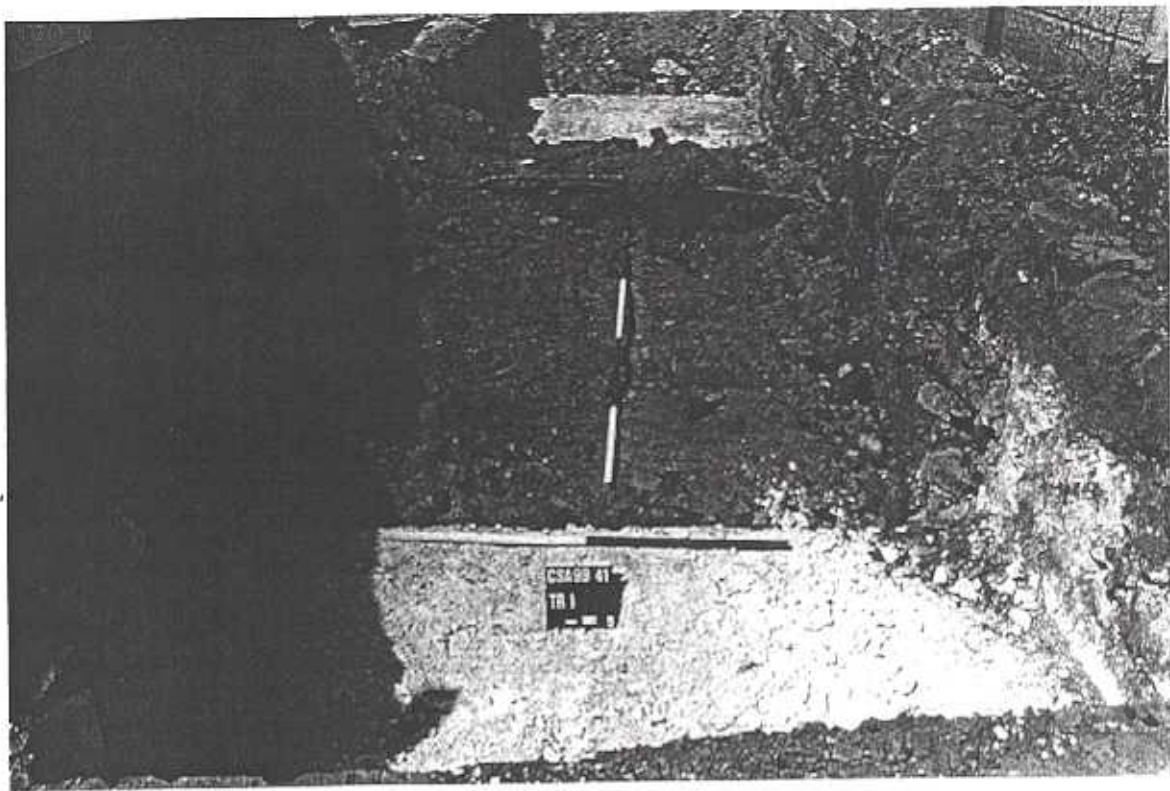
This trench was aligned approximately east-west at the front of the plot between a standing building and the road. It was 9.0 m. long and 0.60 m. deep along most of its length. At the west end tarmac overlay brick rubble made ground which sat directly on solid chalk, the natural geology. Made ground 0.30 m. thick overlay chalk at the eastern end and a 0.60 m. deep backfilled fish pond was removed by machine revealing carpet lining which

again sat directly on the chalk. Two cellars, both backfilled with brick rubble, were located cutting into the chalk, one at the western end of the trench, the other in the centre. The latter was investigated by machine showing it to be at least 2.5 m. deep. No archaeological features or deposits were observed, and no artefacts were found in the spoil.

Plate 1 Chantry Street, Andover. Trench 1 looking west. Scales: 2 m and 1 m.

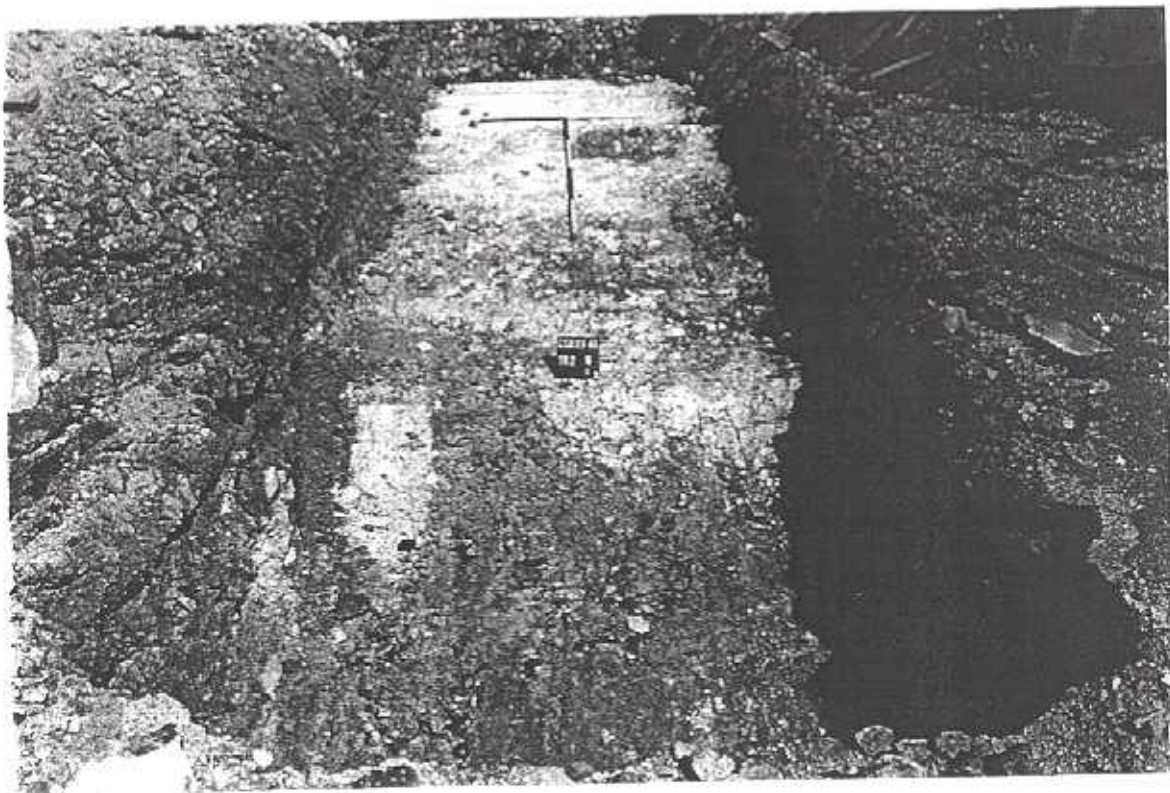
The second trench in the centre of the plot again showed tarmac sealing made ground which directly overlay the natural chalk. It was 8.0 m. long and 0.45 m. deep in the centre although where modern features were revealed at each end they were partially removed by machine to a depth of 0.60 m. A large modern feature at the southern end and two small features in the centre were filled with building material, whilst at the northern end a square brick-lined pit containing modern material (not collected) cut another rubble filled feature. No archaeological features or deposits were observed and no artefacts were recovered.

Plate 2 Chantry Street, Andover. Trench 2 looking north. Scales: 2 m and 1 m.
