**Watlington Road, Benson,  
South Oxfordshire**

**An Archaeological Evaluation  
for Croudace**

Site Code WRB99/62

Report 99/62

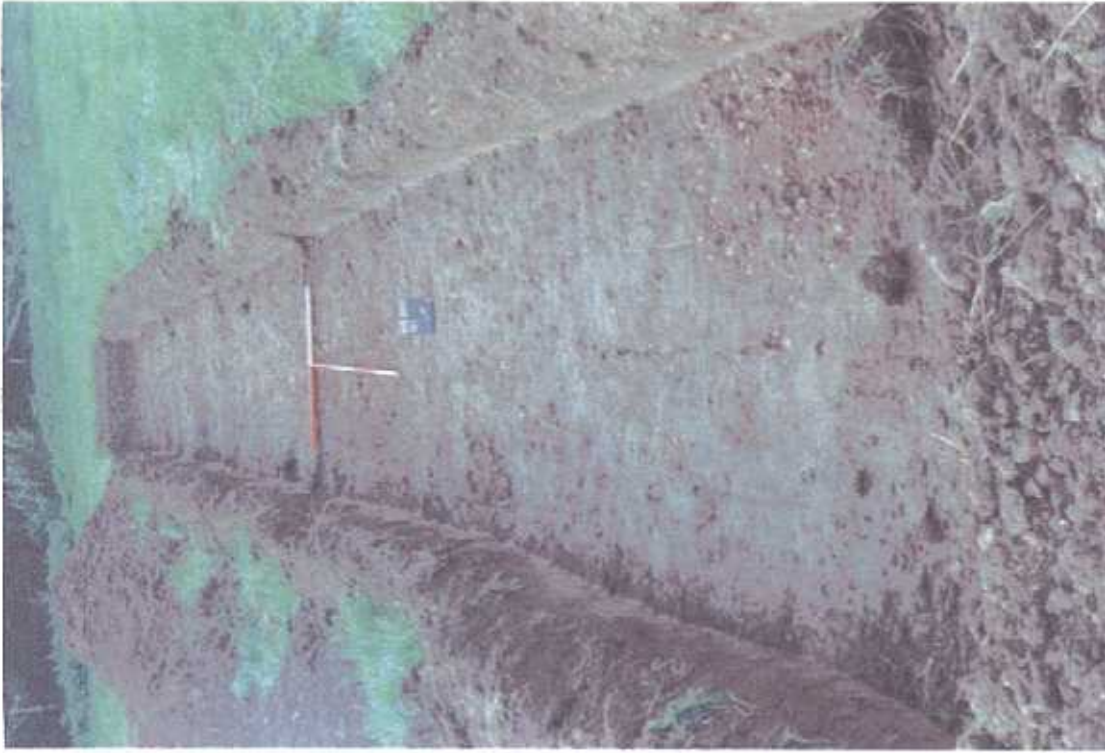
All the trenches were 21.00m long, except Trench 6 which was 22.00m long. The stratigraphy in all the trenches was typically turf and topsoil over a dark brown sandy-clay subsoil onto a dark reddish-brown sandy

clay with gravel/flints (Plates 1 and 2). The depth at which the natural geology was encountered was fairly consistent, with a mean depth of 0.47m. Trenches 1 and 8 were each overcut at one end in order to check the geology and confirm that the appropriate level had been reached. No archaeological features or deposits were present and, although the spoilheaps were thoroughly inspected for artefacts, especially struck flints, none were found.

Plate 1. Trench 7 looking north west, scales: 1m and 2m.

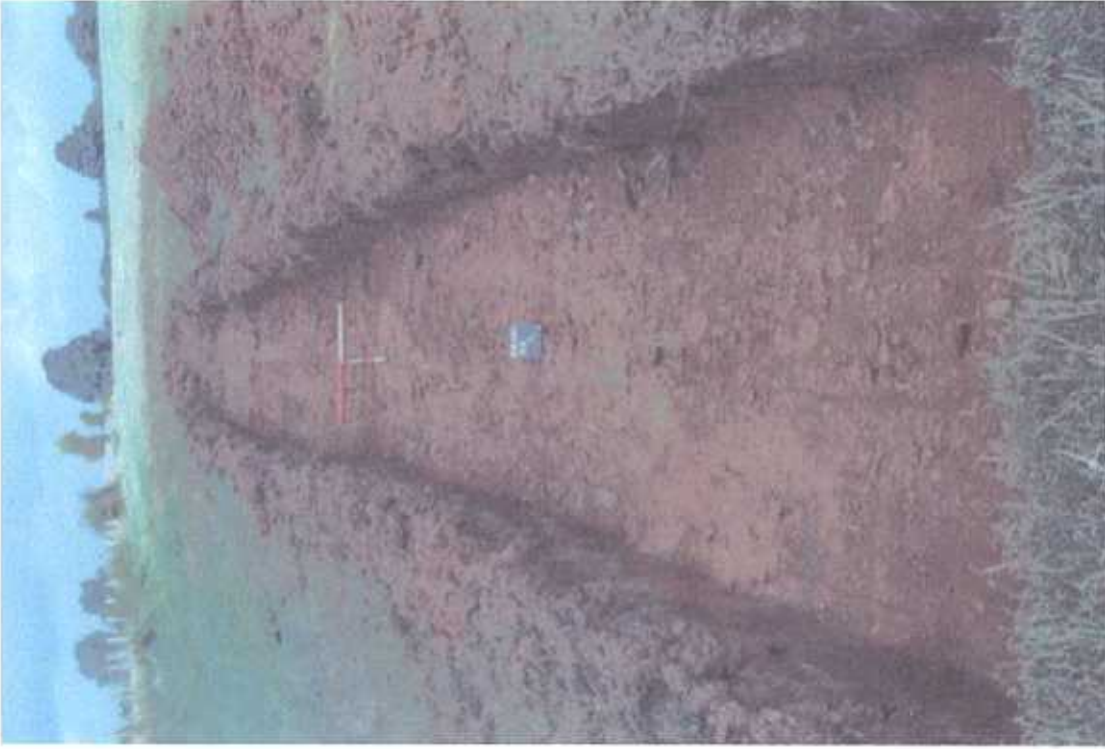
Plate 2. Trench 10 looking north east, scales 1m and 2m.
