Site Code: HMN09/117

## New drainage trenches, North Lodge, Hamstead Marshall, Newbury, West Berkshire

#### **An Archaeological Watching Brief**

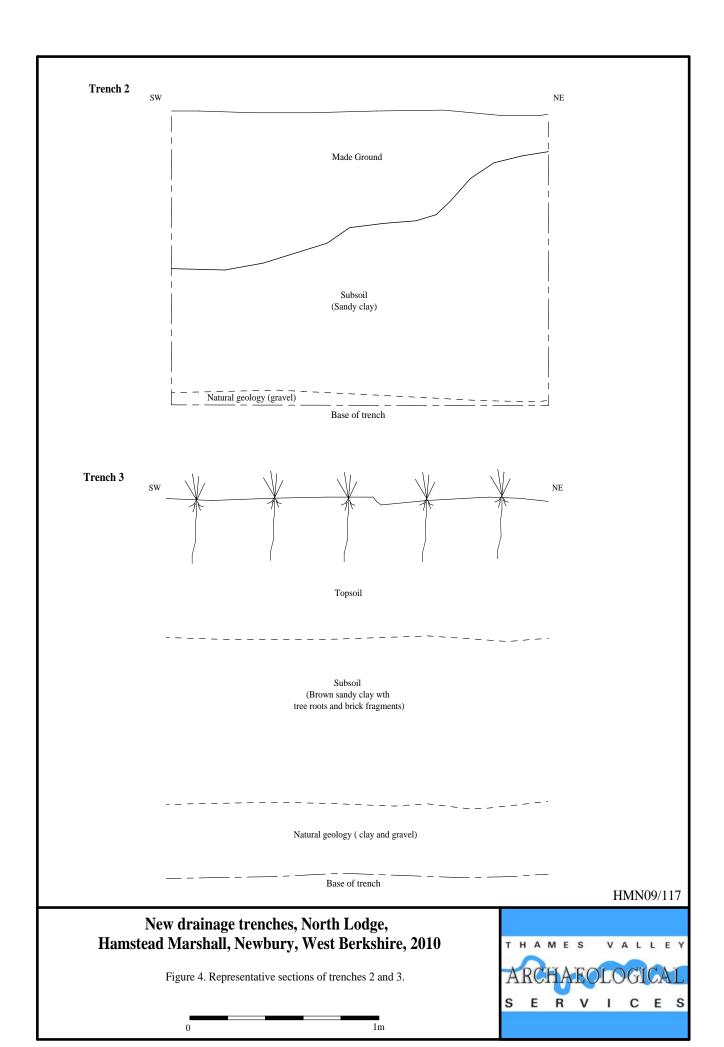
Figure 5. Representative sections of trench 7 at 1m, 40m and 80m and wall at 60m (measured from the north end of the trench).

## Trench 7 at 1m Trench 7 at 23m Topsoil Yellow brown clay Brown grey silty clay Subsoil (Sandy clay with frequent rubble) Brown silty clay Base of trench Subsoil (Sandy clay with rubble) Base of trench Trench 7 at 68m Hardcore 00 Made ground Base of trench Trench 7 wall at 46m Topsoil

This trench followed the route of the 1985 pipe trench which was dug from the west side of North Lodge across the garden and driveway to The Studio. This trench measured 68m in length and was 0.6m wide and up to 1m deep. The majority of the observed stratigraphy reflects disturbed ground associated with the backfilling of the earlier trench. The stratigraphy in the southern half of the trench comprised made ground and subsoil with modern brick and tile inclusions. The northern end of the trench was less disturbed and where the natural geology was seen, it was a mottled yellow/brown clay. No archaeological features were observed in the northern half of the trench. A series of representative sections along the trench were drawn (Fig. 5).

At 46m from the northern end of the trench, just prior to the trench's turning in front of The Studio and close to the pond (Fig. 2), a small section of wall was uncovered (Fig. 5; Pl. 2). The surviving section of brick wall was 1.5m in length, and comprised 3 courses of red brick aligned north—south obliquely across the trench. The size of the bricks (62mm thick x 110mm in breadth and up to 220mm in length) indicates a 19th century date (Harley 1974), assuming they were not re-used. The colour of the brick is a mottled orange red with some purple red in places; flecks of white sand and quartz like inclusions are visible throughout. The wall is likely to

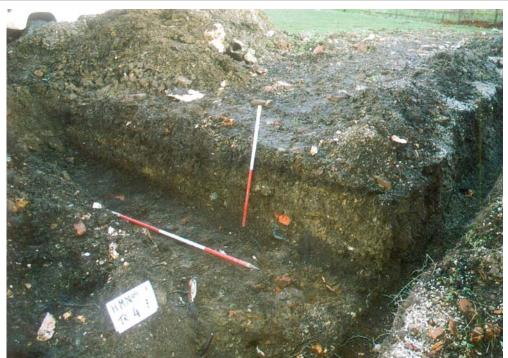
Plate 1. Trench 4, looking north east, scales: 2m and 1m.

Trench 4 was 3.7m, long 0.6m wide and 0.69m deep, and was dug from an electricity pylon to Trench 3 in order to run electricity through the new service trenches. The stratigraphy comprised 0.29m of dark brown/grey sandy silt with root disturbance (Pl. 1). Below this a layer 0.14m thick of orange/brown gravel hardcore was observed. Below this was a subsoil which was heavily disturbed and contained modern building material. Modern (blue and white 20th-century transfer printed wares) pottery found at the base of the trench was not retained. Natural geology was not observed and no archaeological features were recorded.

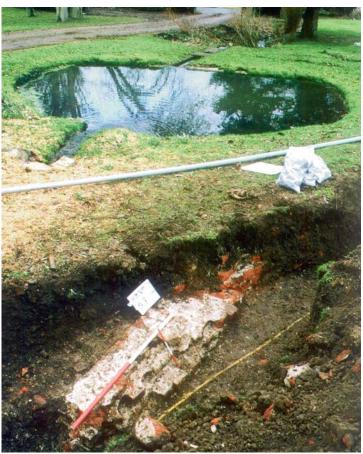
Plate 2. Wall in Trench 7, looking north west. scales: 1m and 0.3m.

be part of an outbuilding associated with The Studio building. In the trench area surrounding the wall large amounts of animal bone were noted. These bones of sheep/goat, cattle and pig were found overlying the 1985 gas and electricity cables indicating possible removal and redeposition at that time. The bones showed butchery marks and a noticeable bias towards phalanges and broken ends of long bones. Ribs and vertebrae were also present in large numbers. One long bone likely to be sheep/goat was found with a wire loop attached at one end perhaps indicating how it was hung; this bone also had extensive incision marks indicating butchery.
