The Vicarage, Hammersley Lane, Tylers Green, Buckinghamshire

An Archaeological Evaluation

Site Code: VTG03/106

Report 03/106

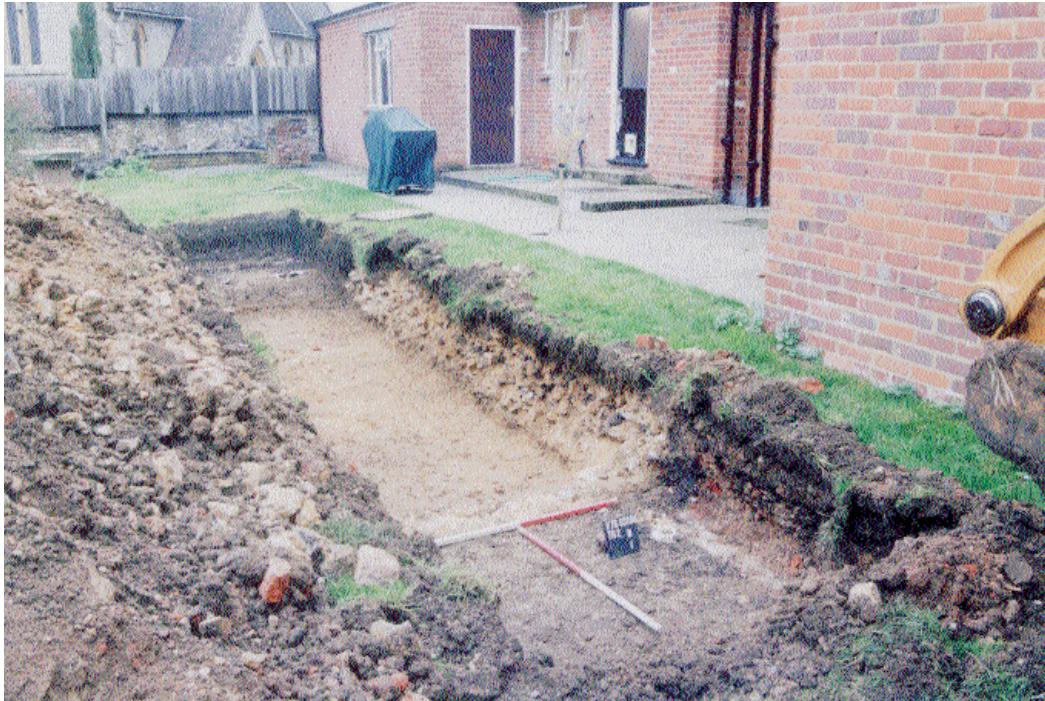
Plate 1. Trench 2, looking north east, walls 2 and 3, scales 0.5m

Trench 2 was 9.8m long. The stratigraphy consisted of turf and topsoil (0.16m) onto mortared flint walls that lay at 161.77m AOD (Features 1, 2 and 3, Fig. 7) (0.5m), onto a foundation (4) for the walls of disturbed brown orange clay with red brick rubble, corroded iron nails and one piece of reinforced glass present (0.1m). This lay on undisturbed basal orange brown clay layers with frequent flint and rounded pebbles. The east facing section consisted of turf and topsoil onto a mixed layer (51), dark brown silty clay with frequent red brick and tile and large scrap iron fragments. A modern disturbance cut into the section and wall 1. This was filled with red brick rubble and slate. Two drainage trenches lay at the northern end of the trench, a further drainage pipe and modern red brick foundation wall were uncovered at the southern end of the trench when it was lengthened to gain a clearer idea of the width of wall 3.

Trench 2 located three walls of a small flint and mortar structure; research into the historic maps suggest that there were no recorded structures on this site until the First Ordnance Survey map of 1874. This shows the original Vicarage building that was probably constructed at the same time as St Margaret's Church to the north. Later maps also show that between 1960 and 1973, major alterations took place to the building including demolition of the rear wing of the original square building and total remodelling of the Vicarage in general. This rear wing is in alignment with the walls of the structure located in Trench 2. With modern finds (glass, brick and tile) recovered from the foundation cut of wall 3, it seems likely that the structure located is of Victorian date,

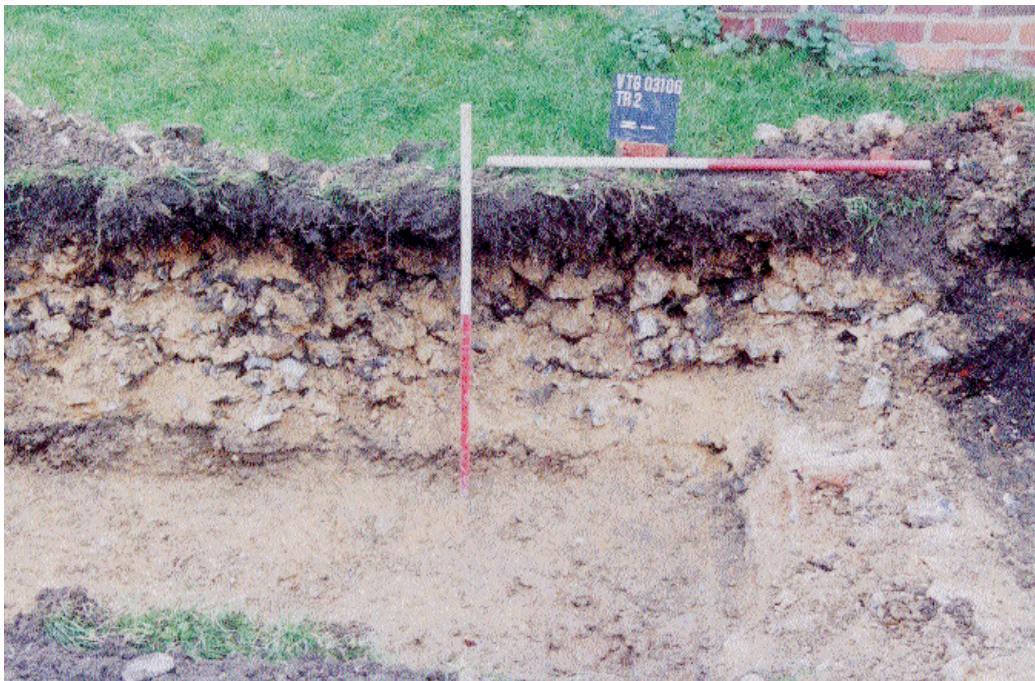
Plate 2. Trench 2, looking east, section of wall 2 scales 0.5m
