**Warren Farm,
Aldworth, West Berkshire**

**Building Recording
For Chesterman Commercial Holdings Limited**

Site Code WFA 04/76a

June 2005

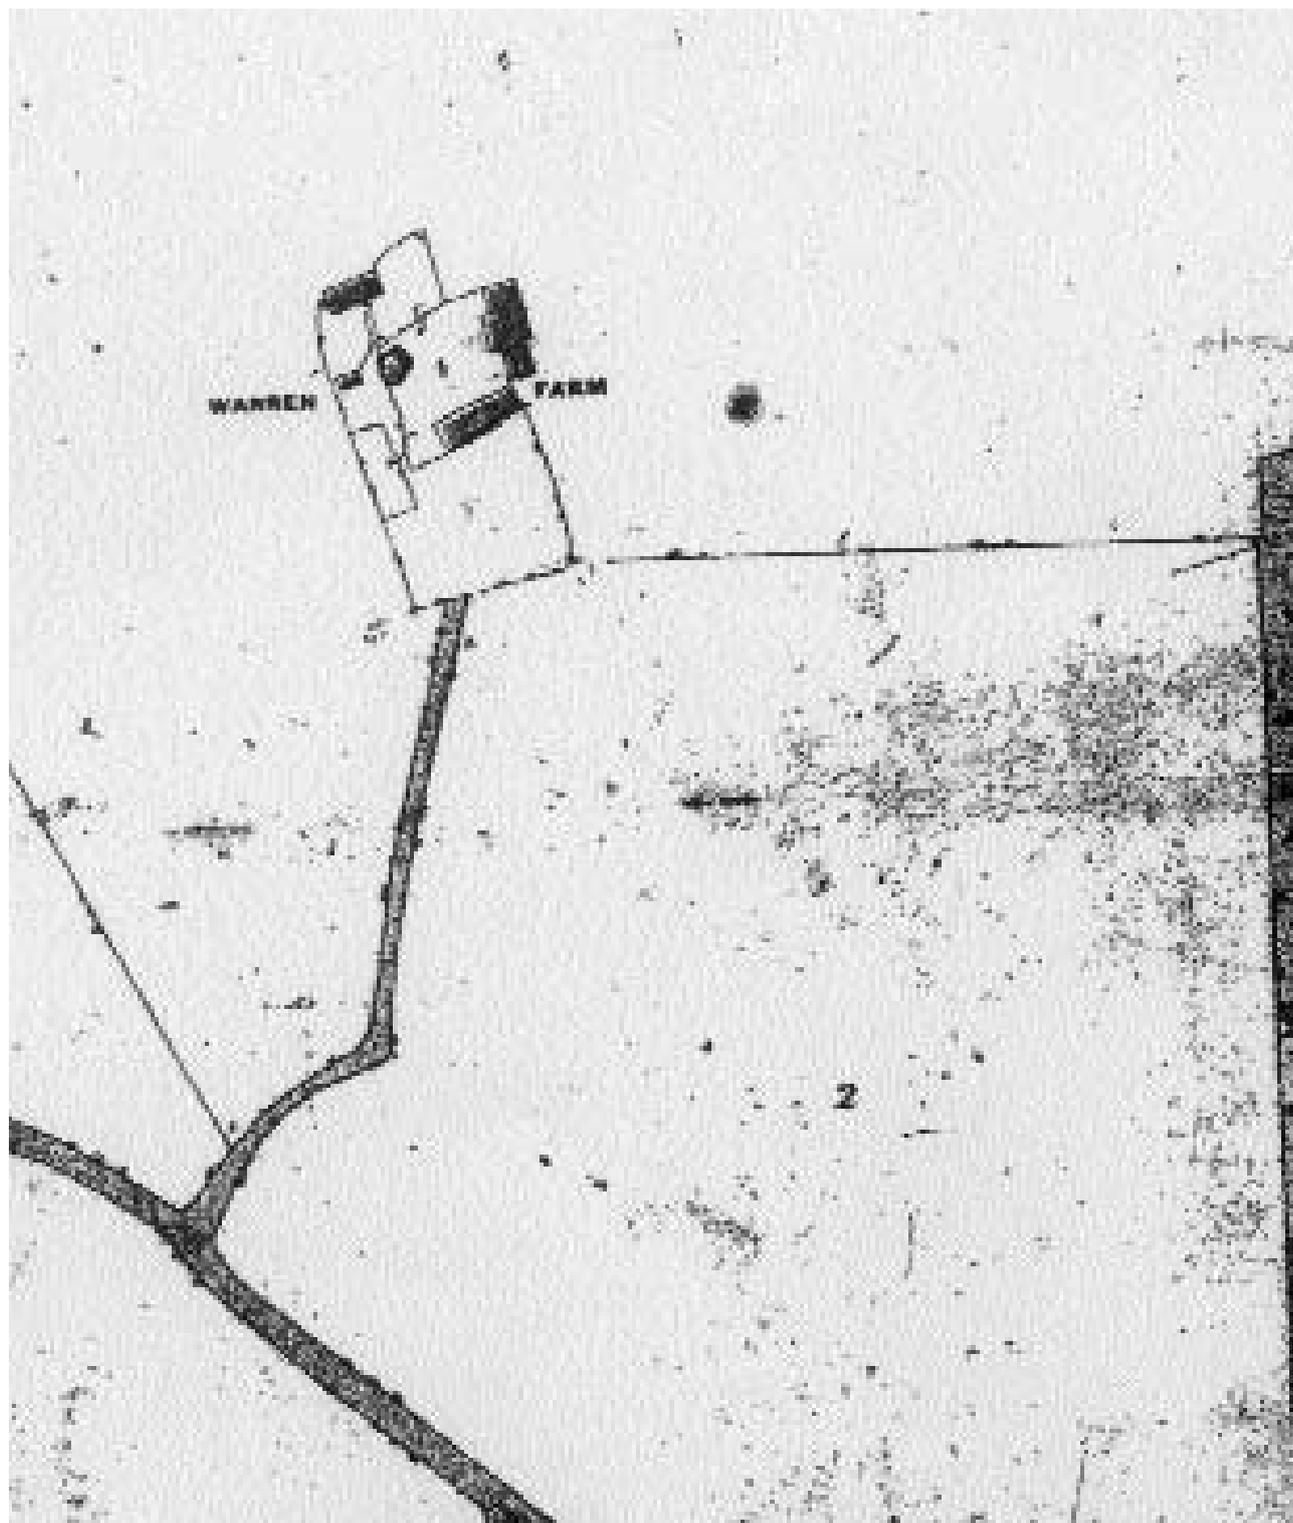
Figure 3. Aldworth Tithe map 1840.

The earliest cartographic sources showing the site area in detail are the Tithe map of 1840 (Fig. 3) and First Edition of the Ordnance Survey of 1877 (Fig. 4). Three of the structures shown on the Tithe Map correspond in position and general dimensions with the structures recorded here although it is not clear if the structures are one and the same or have been rebuilt on the same footprints. The map of 1877 and that of 1912 (not illustrated) show a very similar layout suggesting that they are in fact the same structures as those depicted in 1840.

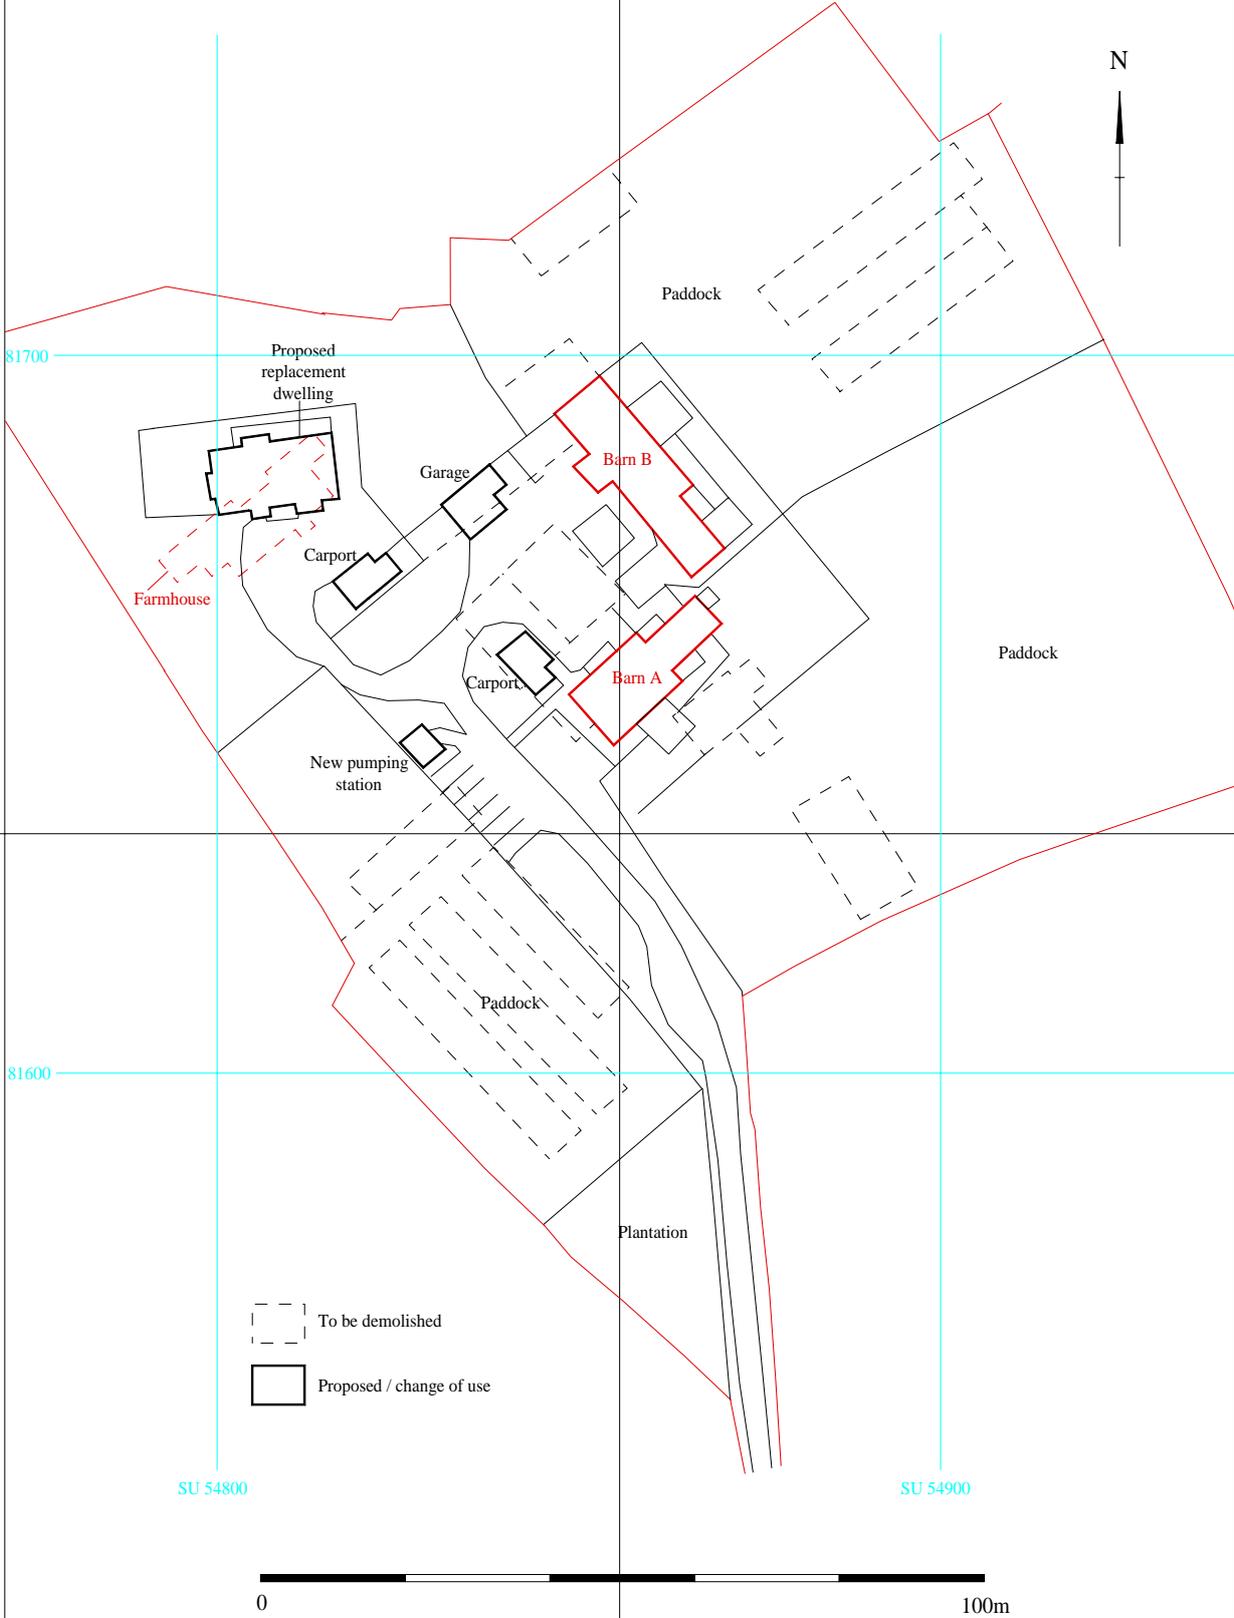
Figure 5. Plan showing location of observed buildings

Warren Farm is a farm complex where the farmhouse is detached from the farm buildings which form a small courtyard (Fig. 5). Other outlying buildings of modern block construction include those that recently housed chickens. Those subject to the planning conditions are the farmhouse, to be demolished, and two barns to be converted to residential use.

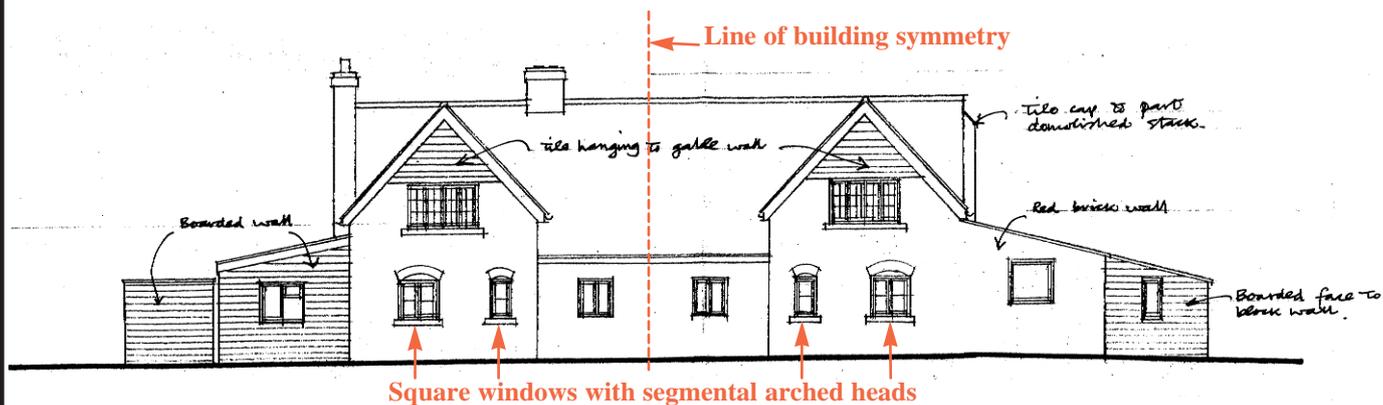
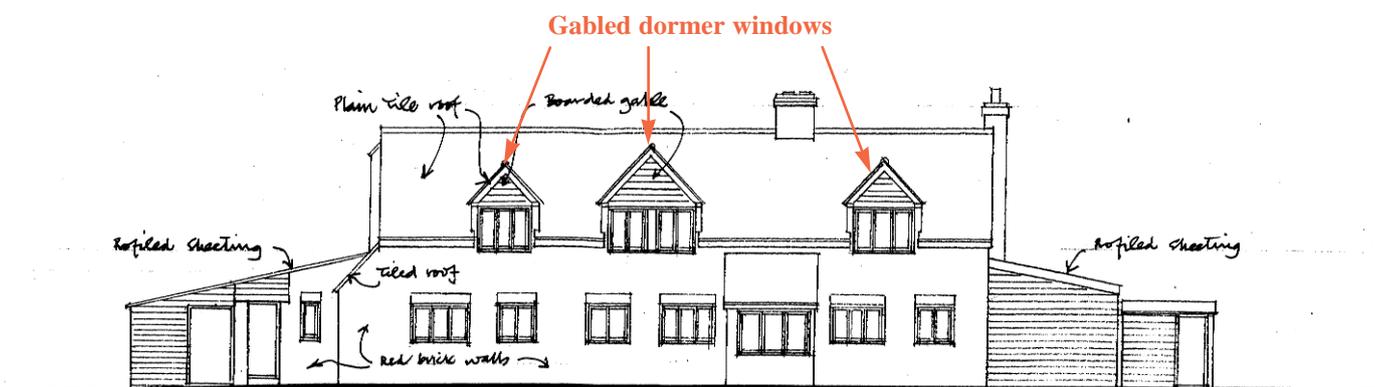
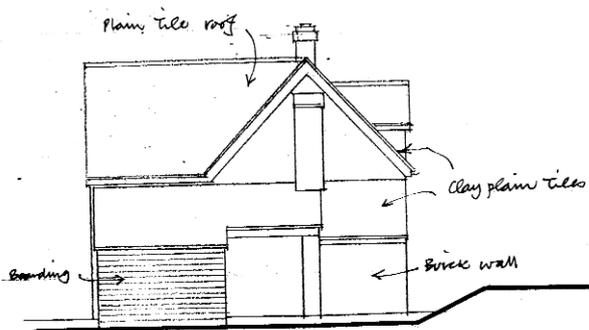
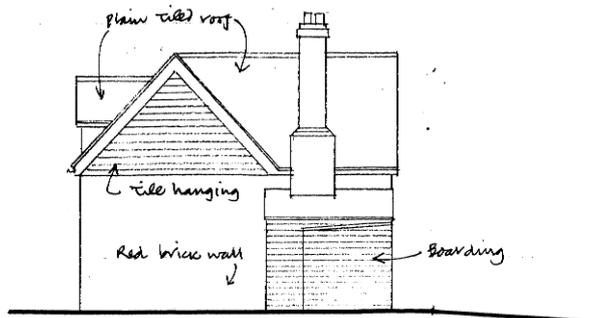
Figure 6. External elevations of farmhouse

The farmhouse is constructed of red brick which has tile hanging with brick underbuild. The house was originally two cottages, as is apparent from the north-west elevation as this shows the building’s symmetry (Fig. 6) (Plate 1). This elevation also indicates that the two cottages form one building which is one storey with two two-storey wings. The south-east elevation shows that three gabled dormer windows inserted to allow more light enable the second storey to be utilized throughout the house and not just in these wings. A single storey extension has been added to the south-western wing and weather boarded lean-to added at both ends. Windows in the south-east elevation are all made of wood and are square; four examples in the north-west elevation are square with segmental arched heads in brick (Fig. 6). The roof is tiled and there are three brick chimney stacks, one has two pots (Pl. 2).

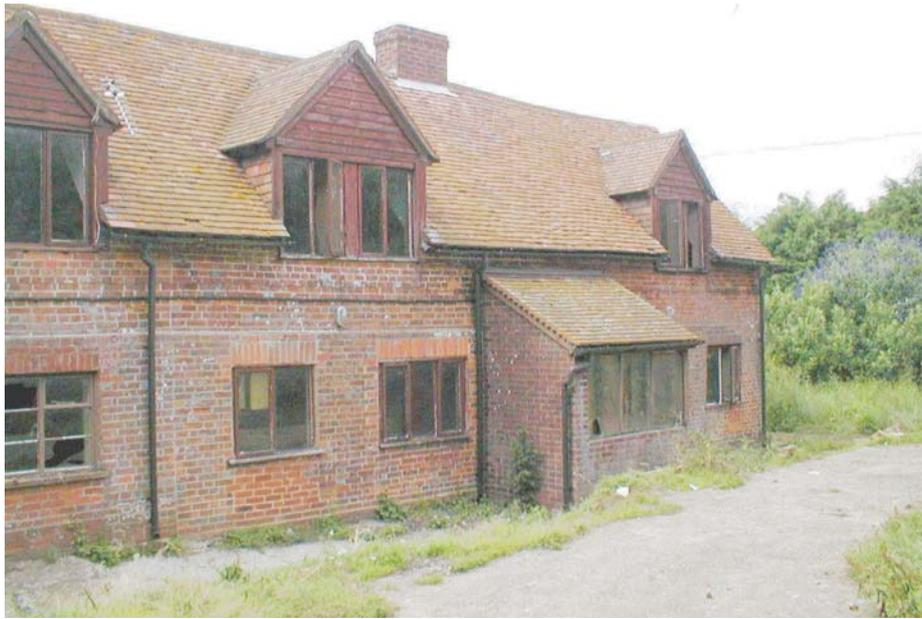
Plate 1. South-east facing elevation

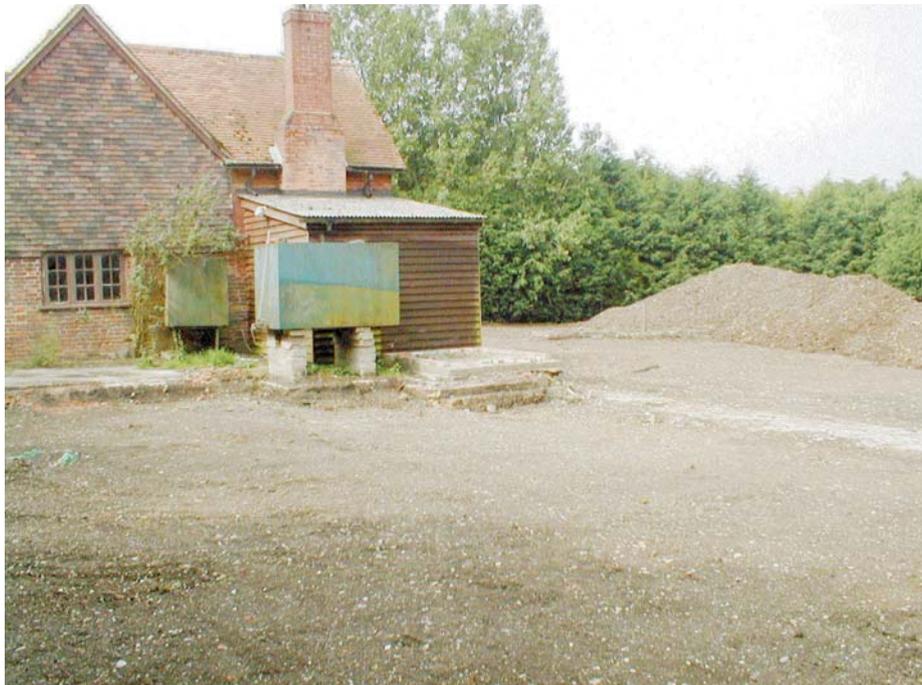
Plate 2. North-east facing elevation

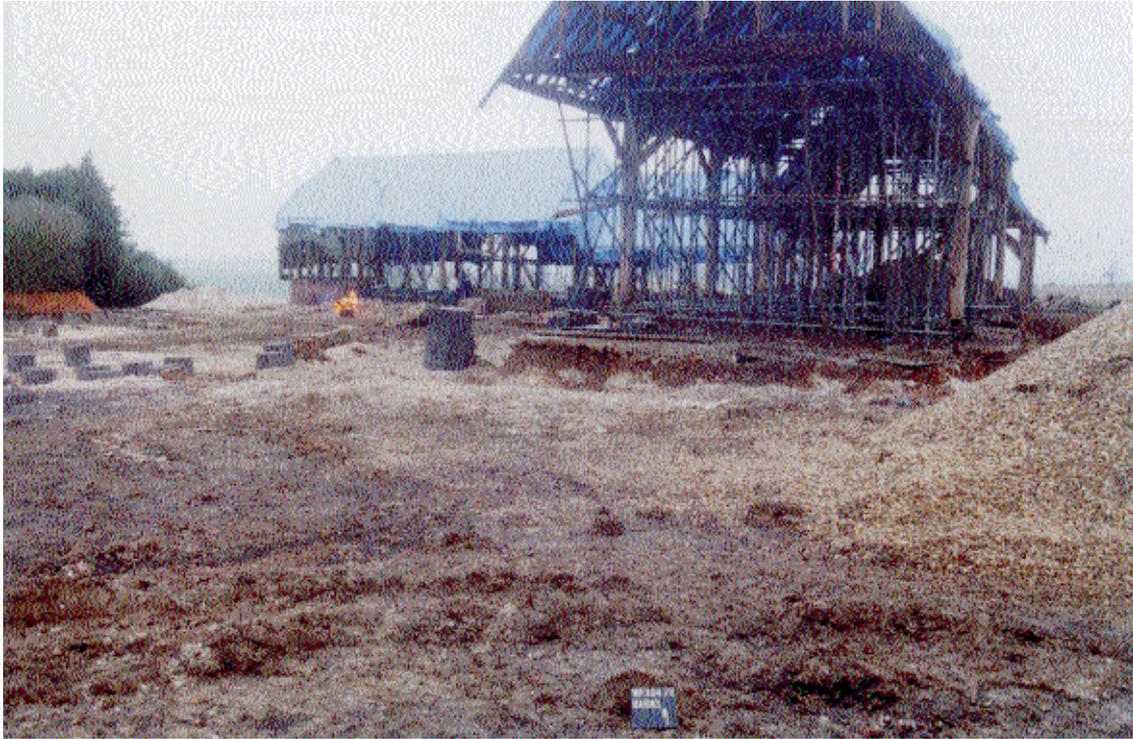
These two barns lie at right angles to one another and to the south-east of the main farmhouse (Fig. 5) (Pl. 3). They are both timber framed structures with horizontal timbers resting on brick plinths (Pl. 4). Both barns are of aisled construction, a central aisle with one aisle on either side. Barn A is smaller in size and comprised of three bays, Barn B is constructed of five bays divided by timber posts. The sides and roofs of both barns probably would originally have been weather boarded or tiled, however, later modernization sees the roofs covered with corrugated metal and some walls replaced with concrete blocks. The aisled barns both have additions to their original structures, possibly from the change or expansion of farming use. These are constructed with concrete blocks and bricks with timber roofs to match those existing. The main purpose of aisled barns were the processing and storage of sheaves with the central bay acting as the threshing floor and the remaining bays used for storage (Brunskill 1992). The roof has a half-hipped end and a gabled porch enabling the extension of the threshing floor.

Plate 3. Barns A and B, looking north

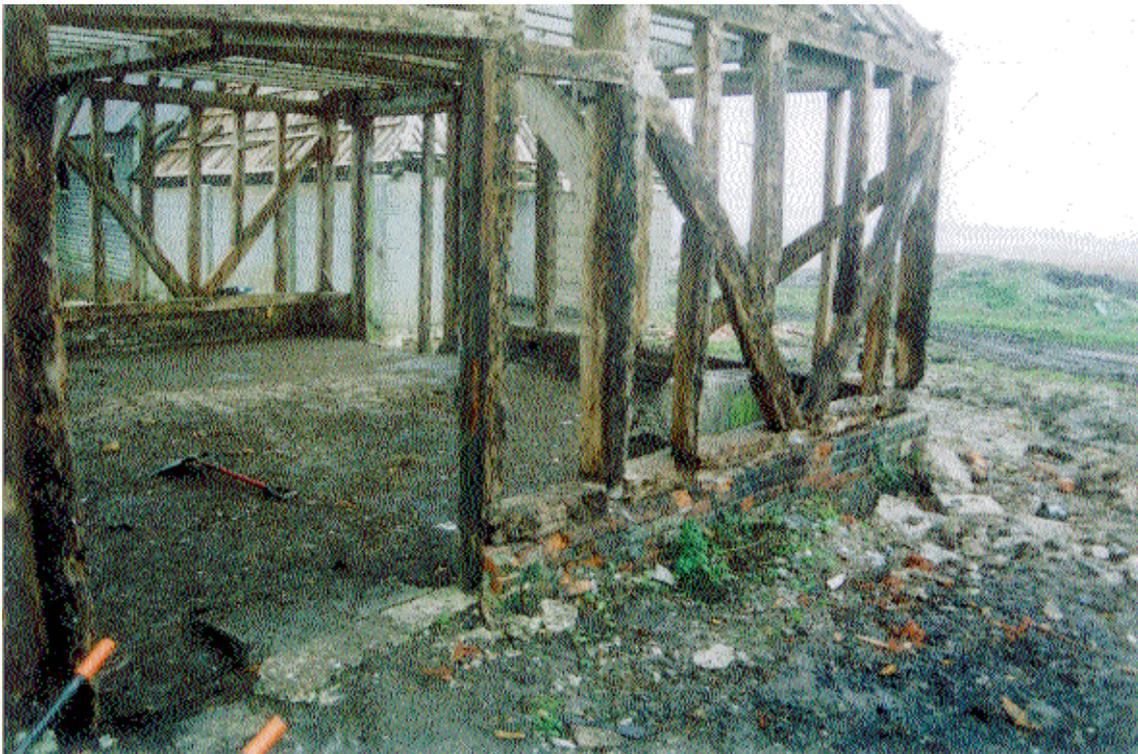
Plate 4. Horizontal timber resting on brick plinth
