Cam Roman Villa

Excavations at Millfields, Cam, Dursley, Gloucestershire

The Villa at Cam

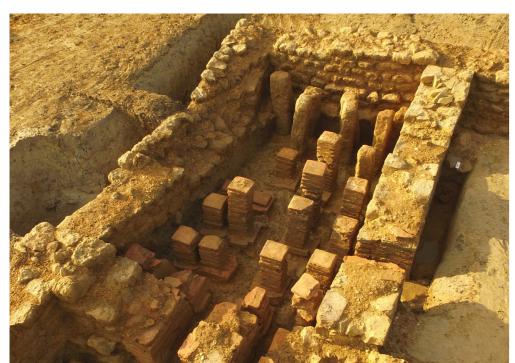
Above: The hypocaust stacks in Room 1.

A furnace, possibly in Room 2, would have been used to heat the air which would then have circulated around the stacks of tiles under the floor of Room 1. A large number of ceramic flue tiles were also found during excavations that would have taken the hot air up through the walls adding extra warmth to the room. Due to very little evidence of burning or heat effects on the hypocaust system there is a chance it was hardly used.

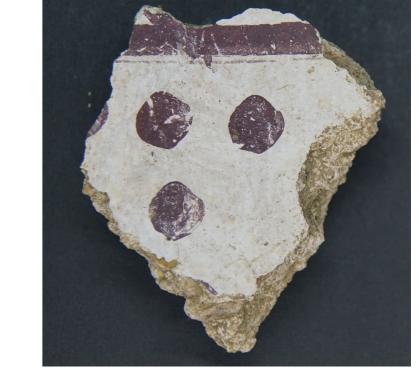
Above: Fragment of painted wall plaster found within the villa.
