T H A M E S V A L L E Y

1st April 1993

Mortimer West End Chapel Restoration Project.
Archaeological Watching Brief.

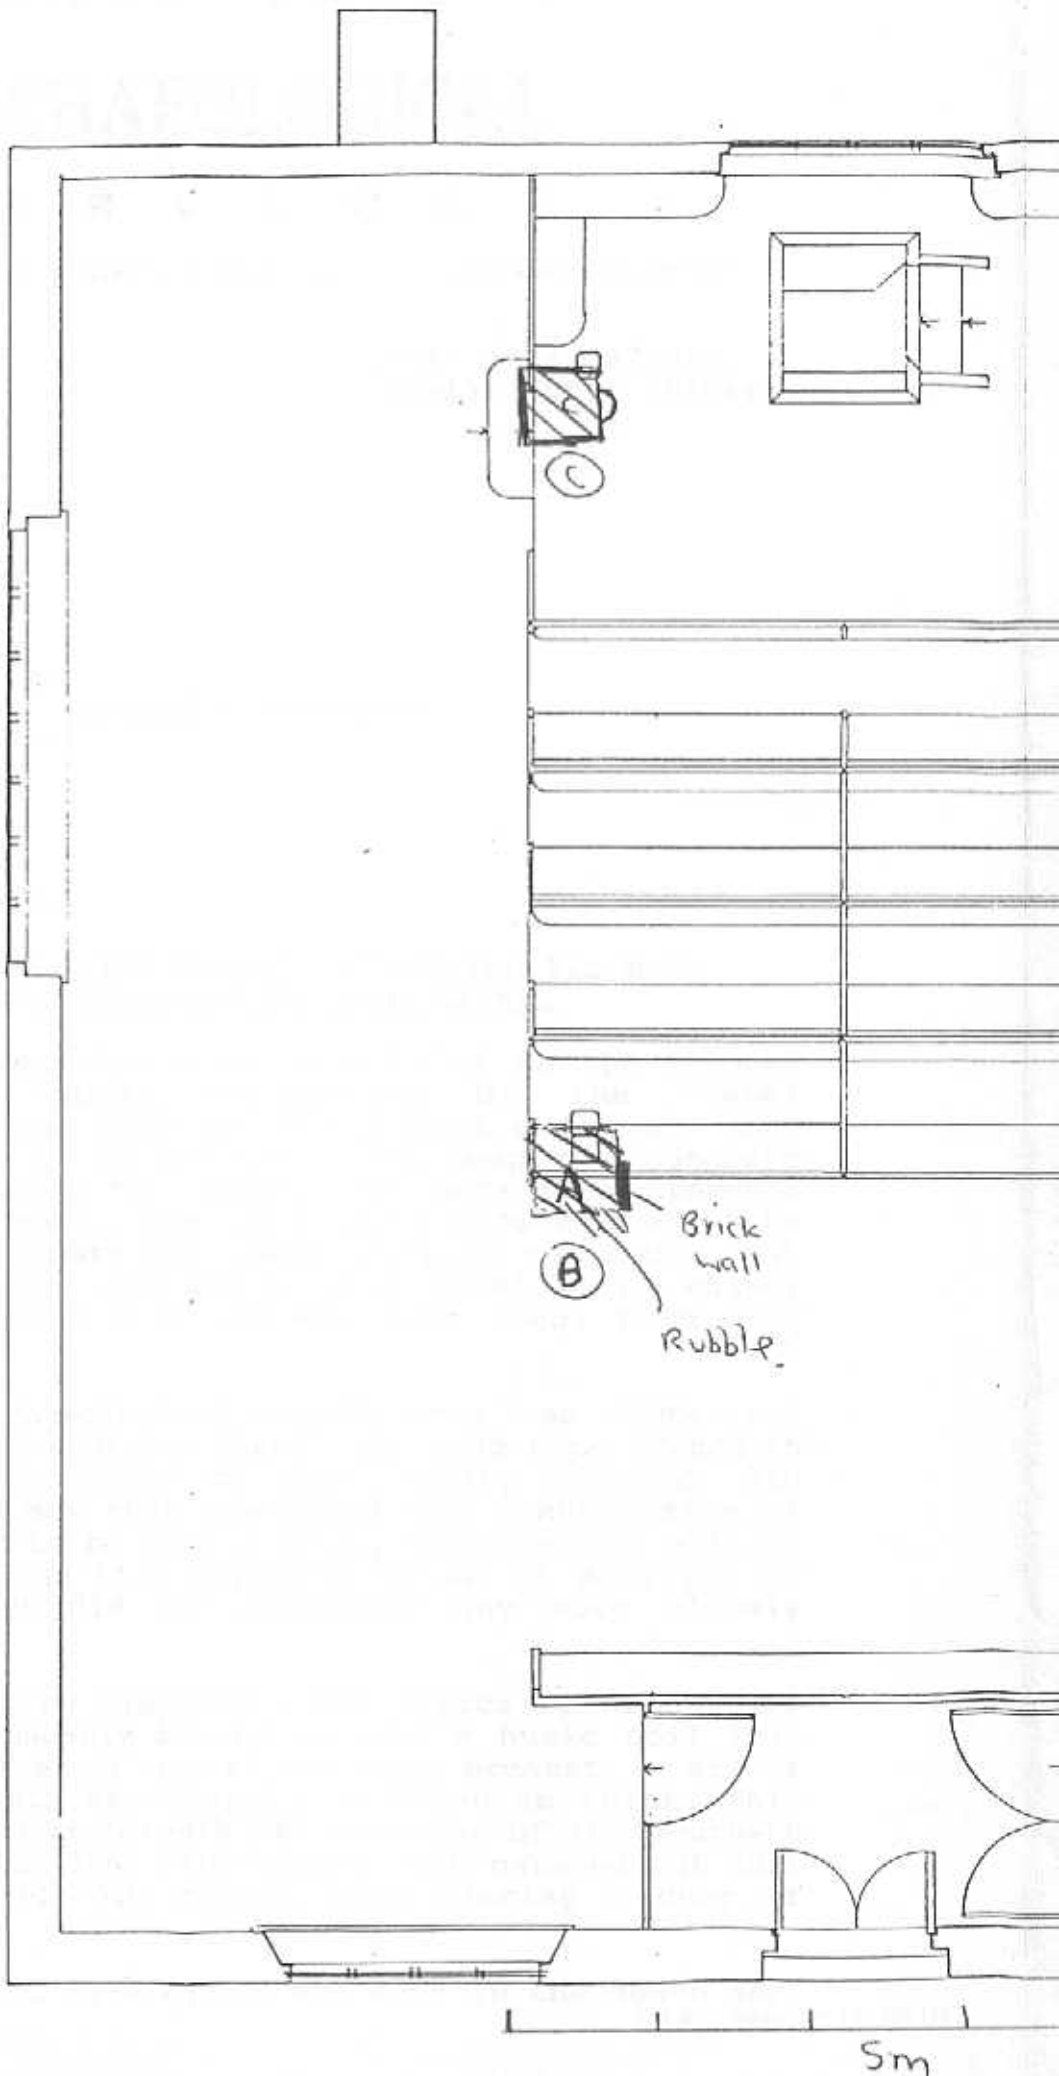
We have now completed a watching brief on the foundation work during restoration of the chapel (SU61666419). Six separate areas were examined. Four were holes c. 1m square and 0.75m deep for concrete foundations within the chapel. Two were pipe trenches. The long one was c. 10m long, 0.5m wide and 0.6-0.8m deep. It ran beneath the chapel wall in the south east corner. The small one was located outside the chapel wall to the north east and was 1.2m long, 0.5m wide 0.9m deep.

Nothing of archaeological significance was discovered pre-dating Post-Medieval times. The long pipe trench in the south east corner of the chapel, however, did locate tile dumps that pre-dated the construction of the chapel, or to be more precise, the southern wall of the chapel. The tile appeared to be of Medieval or later date but did not accompany any more closely datable finds.

Bedrock (a yellow clay/silt) was typically about 0.6m deep and was usually buried beneath a humic soil (old topsoil). A layer of gravel was also present in all of the holes within the chapel, c. 0.1-0.2m thick. This gravel was present beneath the footings of the southern wall seen in the long pipe trench but petered out just beyond the wall. The gravel also overlay a dump of tiles.
