**Ferry Nab, Ferry Lane, Medmenham,
Marlow, Buckinghamshire**

An Archaeological Watching Brief

Site Code FNM03/121

August 2004

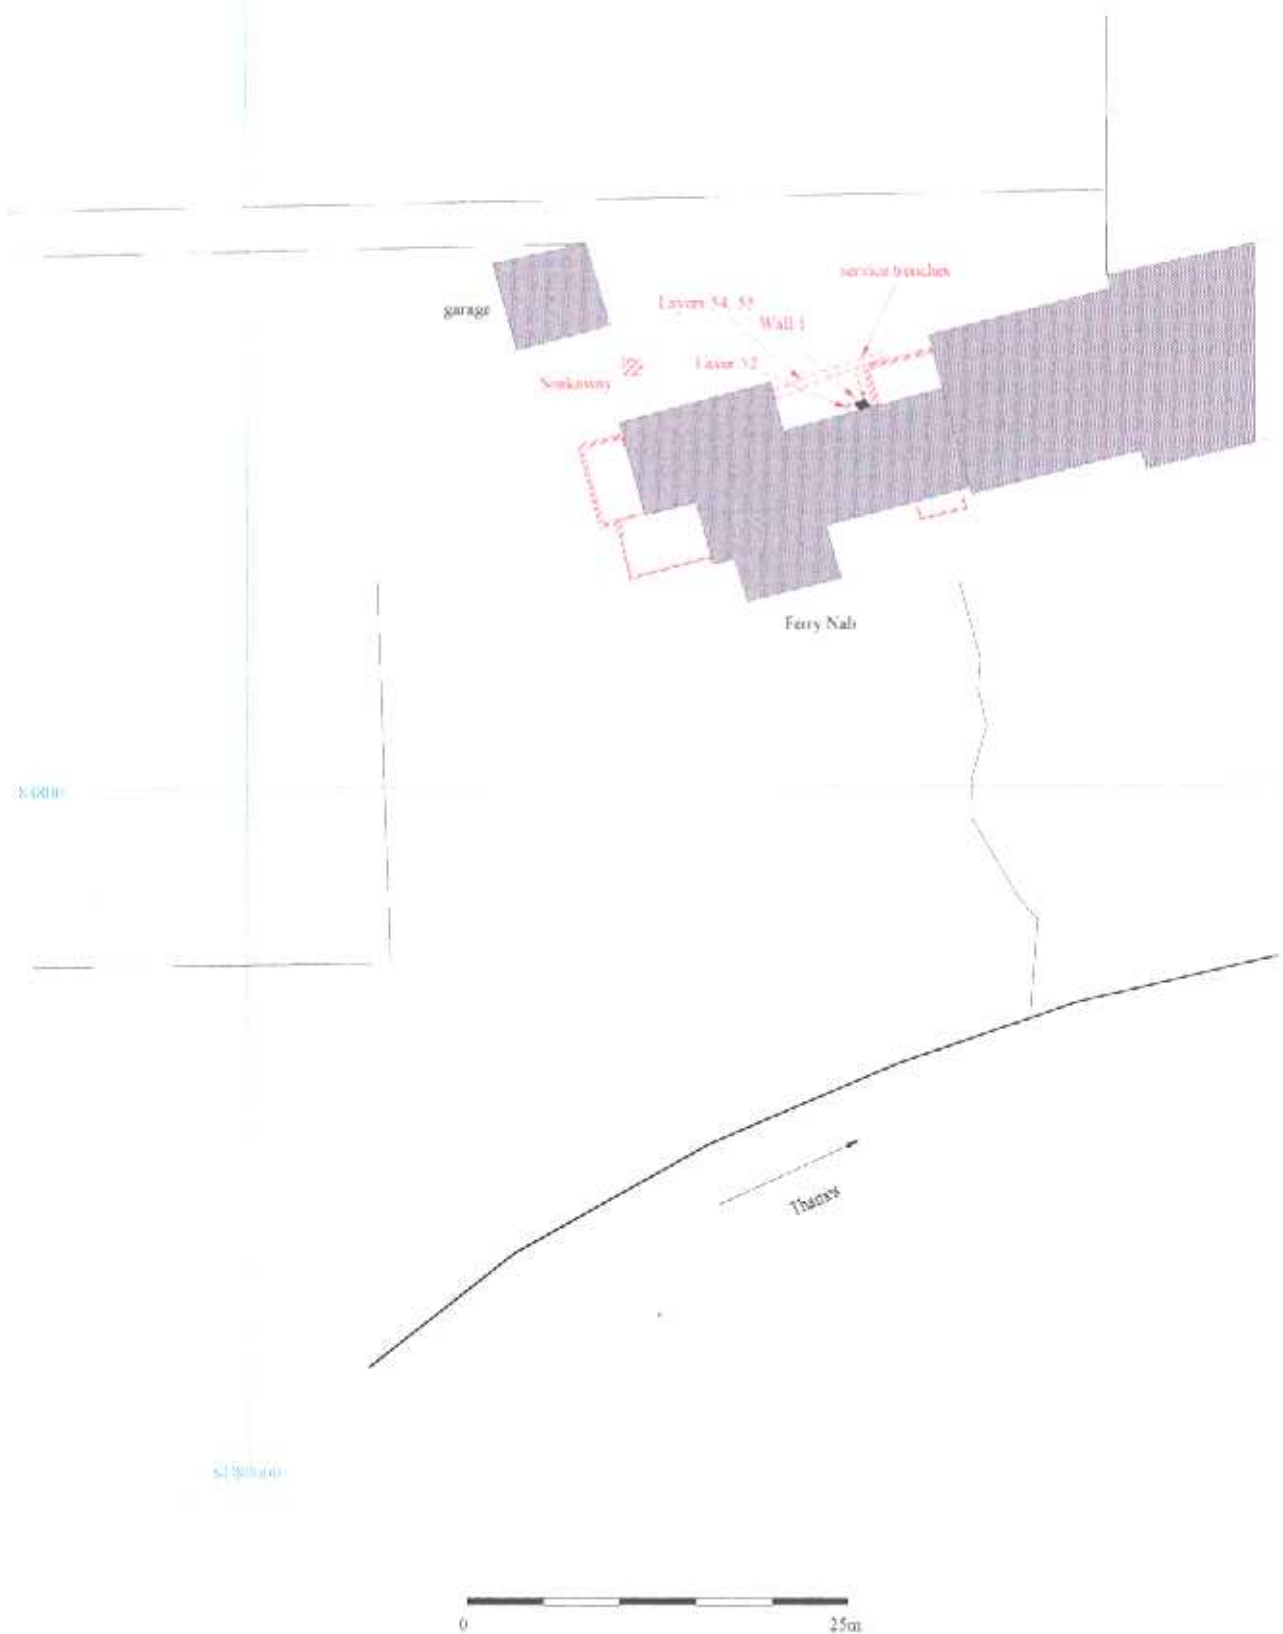
Figure 3. Location of watching brief observations.

In a pipe trench on the north side of the building a chalk-built wall was observed (Figs. 3 and 4). This comprised chalk blocks, mostly sub-rounded and 0.1m across with some flint nodules (50). It was set within a construction cut (1) which had been backfilled with a sandy clay containing chalk pieces, the occasional flint nodule and with

A second pipe trench was dug across the northern part of the house which was between 0.49m and 0.8m deep and 0.4m to 0.9m wide. Below the surface, made ground to a depth of 0.7m was observed overlying a hard packed chalk layer (54) which was 0.07m thick. This layer may be the same as (52) recorded to the south. This in turn overlay a dark brown/grey silty clay with chalk flecks and charcoal (55). The natural geology (gravel) was not observed. No dating evidence was recovered for the two layers which might represent floor surfaces, or possibly consolidation layers again for flood prevention. Many services trenches were noted for the house. The wall recorded previously to the south was not observed.
